STATE OF CONNECTICUT
 CONNECTICUT HISTORICAL COMMISSION
 59 SOUTH PROSPECT STREET, HARTFORD, CONNECTICUT 06106
 (203) 566-3005

1. BUILDING NAME (Common)		(Historic)	
Lyman House			
2. TOWN / CITY		VILLAGE	COUNTY
Manchester			Hartford
3. STREET AND NUMBER (and / or location)			
943 Middle Turnpike East

NAME	DATE
Geoffrey Rossano	April 1998
ORGANIZATION	
Town of Manchester	
ADDRESS	
41 Center Street, Manchester 06045

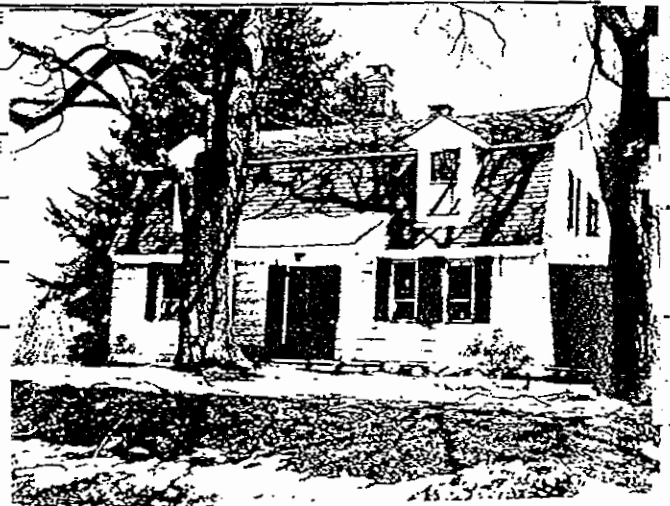
11. NUMBER OF STORIES	APPROXIMATE DIMENSIONS		
1-1/2	33' x 24'		
12. CONDITION (Structural)		(Exterior)	
<input type="checkbox"/> Excellent	<input checked="" type="checkbox"/> Good	<input type="checkbox"/> Fair	<input type="checkbox"/> Deteriorated
<input type="checkbox"/> Excellent	<input checked="" type="checkbox"/> Good	<input type="checkbox"/> Fair	<input type="checkbox"/> Deteriorated

943 Middle Turnpike East is an attractive 1-1/2-story gambrel-roofed Cape, oriented with the long elevation to the street. The structure rests on a stone foundation and is sheathed with replacement aluminum siding. The building incorporates a central entry and shed-roofed entry porch with turned columns and sawn brackets. Window sash is of paired six-light configuration. Architectural features include a side entry porch (right) with turned columns and two gable dormers in the street elevation.

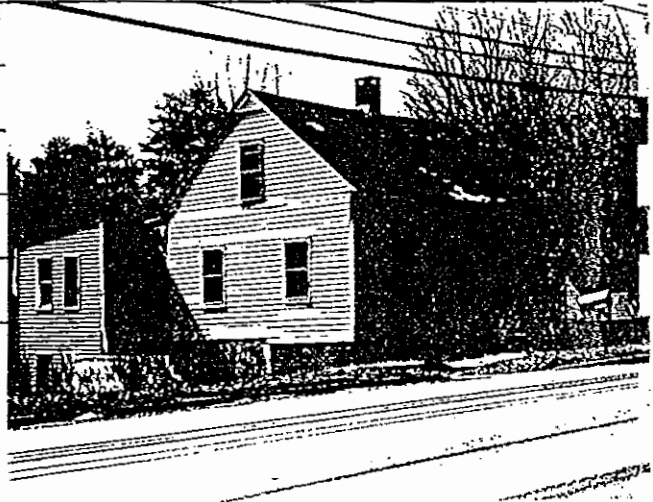
11. NUMBER OF STORIES 1-1/2 APPROXIMATE DIMENSIONS 24' x20'	
	12. CONDITION (Structural) _____ (Exterior) _____ <input type="checkbox"/> Excellent <input checked="" type="checkbox"/> Good <input type="checkbox"/> Fair <input type="checkbox"/> Deteriorated <input type="checkbox"/> Excellent <input checked="" type="checkbox"/> Good <input type="checkbox"/> Fair <input type="checkbox"/> Deteriorated

584 North Main Street is a very simple 1-1/2-story vernacular frame cottage with a gable roof, oriented with the long elevation to the street. The structure rests on brick foundation and is sheathed with clapboards. The building incorporates a central entry and window sash is of 2/2 configuration arranged in a two-bay facade. Architectural features include a small central chimney and modern framed additions in the rear.

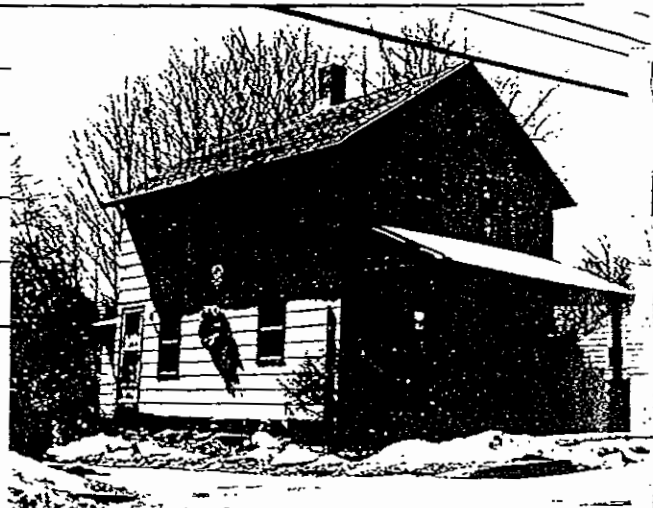
590 North Main Street is a simple two-story vernacular frame residence with a gable roof, oriented with the gable end to the street. The structure rests on a brick foundation and is sheathed with replacement asbestos siding. The building incorporates an offset entry (front/right) and full-width shed-roofed porch with square columns. Window sash is of 2/2 configuration arranged in a two-bay facade. Architectural features include a diamond-shaped window in the gable peak, small central chimney, one-story gabled ell in the rear, and one-story shed-roofed addition at the right/rear.

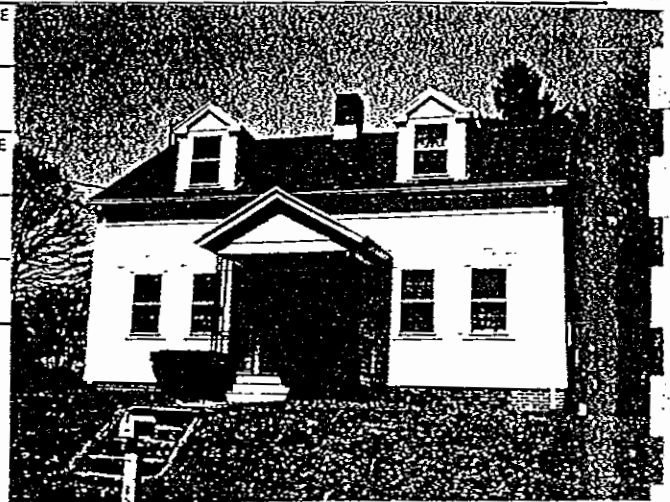
11. NUMBER OF STORIES 1-1/2	APPROXIMATE DIMENSIONS 32' x 24'
12. CONDITION (Structural) _____ (Exterior) _____	
<input type="checkbox"/> Excellent <input checked="" type="checkbox"/> Good <input type="checkbox"/> Fair <input type="checkbox"/> Deteriorated	<input type="checkbox"/> Excellent <input checked="" type="checkbox"/> Good <input checked="" type="checkbox"/> Fair <input type="checkbox"/> Deteriorated

611 North Main Street is a simple 1-1/2-story Cape-style frame residence with a gable roof, oriented with the long elevation to the street. The structure rests on a brick foundation and is sheathed with clapboards. The building incorporates a central entry with sidelights and pilaster-and-lintel surround and a gabled entry hood. Window sash is of 6/6 configuration arranged in a five-bay facade. Architectural features include molded eaves/returns, small central chimney, and two gabled dormers in the street elevation.

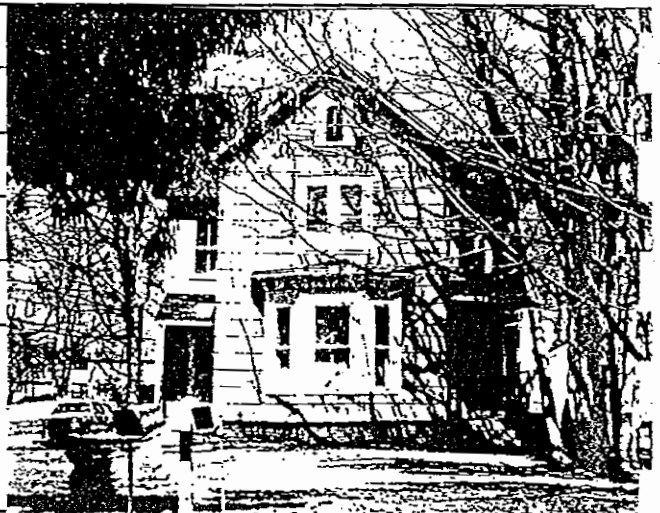
619 North Main Street is a simple two-story vernacular frame residence with a gable roof, oriented with the gable end to the street. The structure rests on a brick foundation and is sheathed with replacement asphalt siding. The building incorporates offset entries on the right and left with small modern entry porches. Window sash is generally of 2/2 configuration. Architectural features include two-story cross-gabled wings on the right and left, bracketed eaves, prominent polygonal bay window with bracketed eaves in the street elevation, a similar bay window on the right, round-arched window in the gable peak, and one-story gabled ell with entry on the right incorporating a small entry hood supported by large sawn brackets.

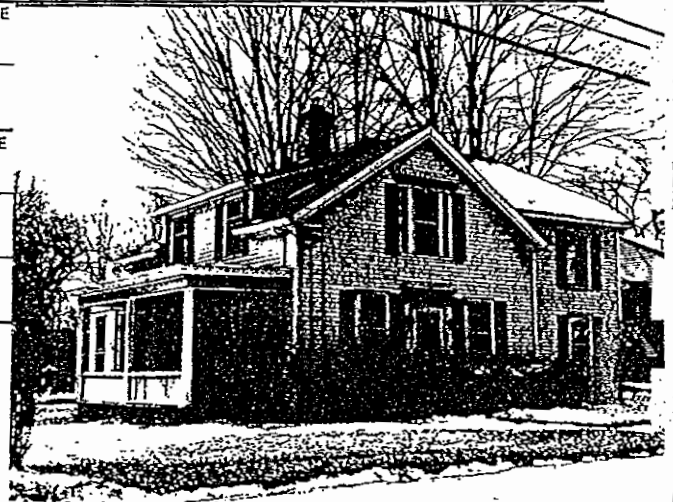
11. NUMBER OF STORIES 1-1/2	APPROXIMATE DIMENSIONS 22' x 30'	
12. CONDITION (Structural)		
<input type="checkbox"/> Excellent	<input checked="" type="checkbox"/> Good	<input type="checkbox"/> Fair
<input type="checkbox"/> Excellent	<input type="checkbox"/> Good	<input type="checkbox"/> Fair
<input type="checkbox"/> Deteriorated	<input type="checkbox"/> Deteriorated	<input type="checkbox"/> Deteriorated

622 North Main Street is a much-expanded 1-1/2-story Greek Revival-style frame cottage with a gable roof, oriented with the gable end to the street. The structure rests on a brownstone foundation and is sheathed with replacement vinyl siding. The building incorporates a central entry with pilaster-and-lintel surround. Window sash is of 2/1 configuration arranged in a two-bay facade. Architectural features include tripartite window with molded entablature in the gable peak, two-story wing on the left with jerkin-headed roof, shed dormer on the right, bay window on the right, simple eaves returns, and side porch on the right.

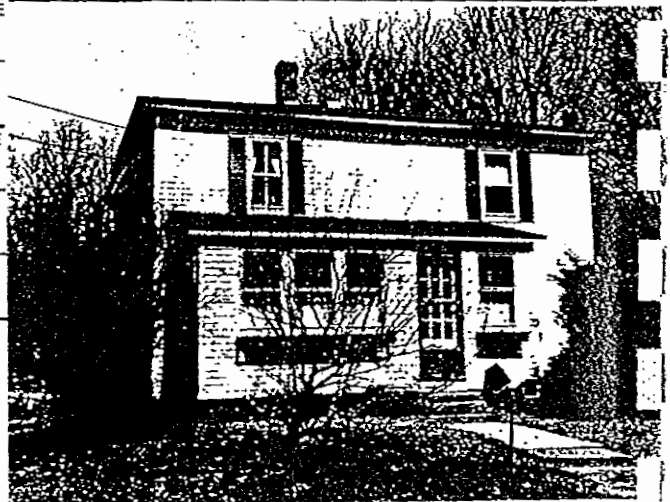
631 North Main Street is a very simple two-story vernacular Italianate-style frame residence with a hip roof. The structure rests on a brownstone block foundation and is sheathed with replacement vinyl siding. The building incorporates a central entry and enclosed shed-roofed porch. Window sash is of 1/1 configuration arranged in a two-bay facade. Architectural features include a small central chimney.

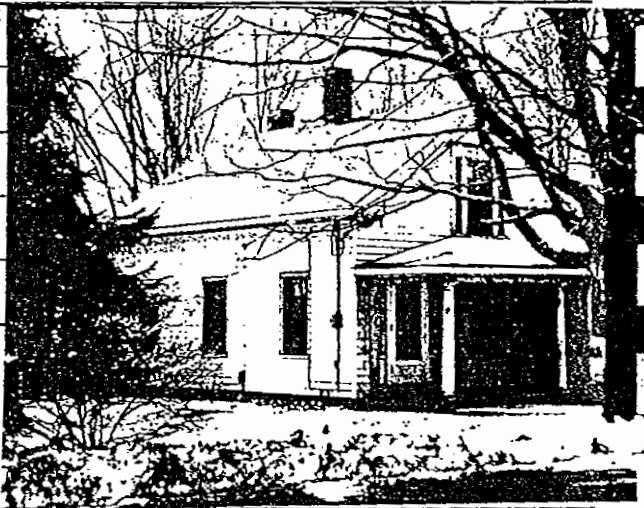
698 North Main Street is a diminutive 1-1/2-story Greek Revival-style frame cottage with a gable roof, oriented with the gable end to the street. The structure rests on a stone foundation and is sheathed with clapboards. The building incorporates an offset entry (front/left) with sidelights and pilaster-and-lintel surround and a full-width hip-roofed porch with Tuscan columns. Window sash is of 6/6 configuration and there is a shed-roofed dormer on the right.

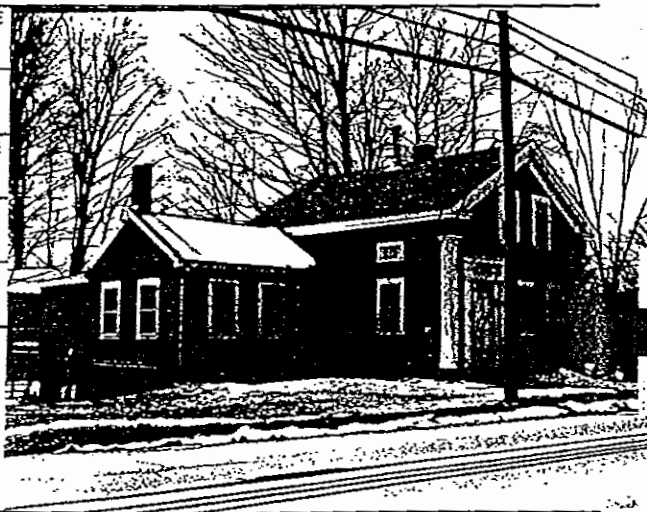
706 North Main Street is a lovely 1-1/2-story Greek Revival-style frame cottage with a gable roof, oriented with the gable end to the street. The structure rests on a stone and brick foundation and is sheathed with replacement vinyl siding. The building incorporates an offset entry (front/left) and prominent pilaster-and-lintel surround. Window sash is of mixed 2/2 and 6/6 configuration arranged in a three-bay facade. Architectural features include a one-story gabled wing on the left, wide paneled Doric corner pilasters, frieze windows in the side elevations, wide rake, and simple eaves returns.

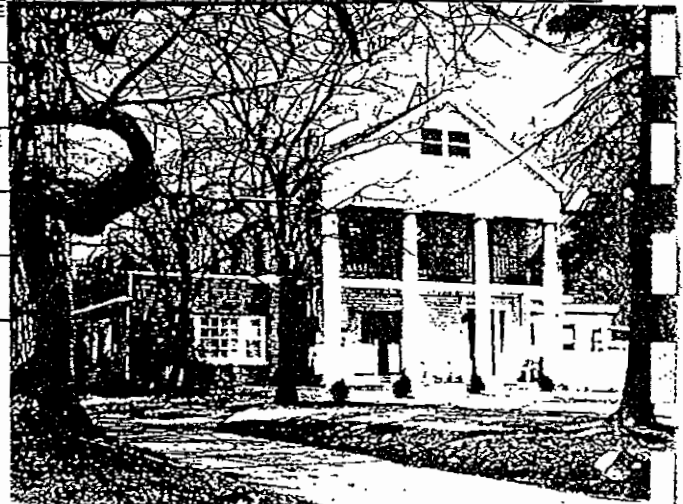
729 North Main Street is a substantial two-story Greek Revival-style residence with a gable roof, oriented with the gable end to the street. The structure rests on a brownstone foundation and is sheathed with clapboards. The building incorporates an offset entry (front/right) with sidelights and pilaster-and-lintel surround. Window sash is of replacement 1/1 configuration arranged in a three-bay facade. Architectural features include a monumental two-story Doric portico with a second-story porch running across its length, rectangular sash in the gable peak, small 1-1/2-story gabled wing on the left, and a small new brick addition on the right.

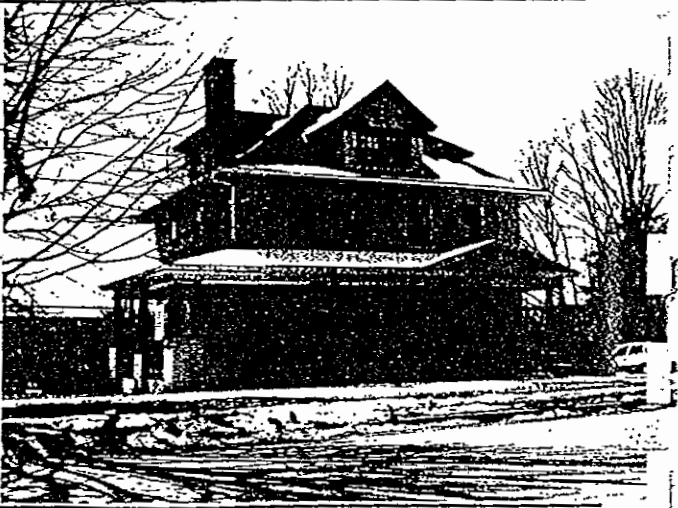
756 North Main Street is a very substantial two-story Foursquare-type frame residence with a hip roof. The structure rests on a concrete foundation and is sheathed with clapboards and shingles. The building incorporates an offset entry (front/right) and very large wraparound porch with bulbous Tuscan half-columns on yellow brick piers, turned balusters, and broad gabled entry peak. Window sash is of 1/1 configuration arranged in a balanced four-bay facade. Architectural features include a gable dormer with molded eaves/returns and paired 6/1 sash in the street elevation, hipped dormers on the right and left, and prominent chimney with corbeled caps.

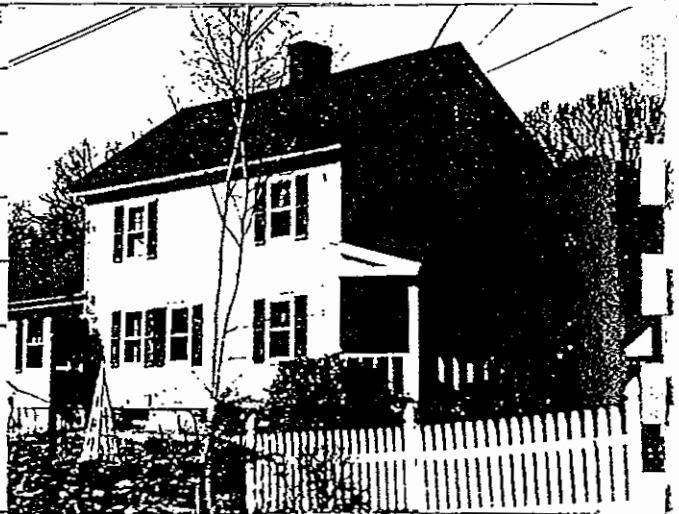
30 Oak Grove Street is a simple two-story vernacular frame residence with a gable roof, oriented with the gable end to the street. The structure rests on a stone foundation and is sheathed with replacement aluminum siding. The building incorporates an offset entry (front/right) and wraparound porch with square columns and gabled entry peak. Window sash is of 6/1 configuration and architectural features include a 1-1/2-story gabled ell, small central chimney, and simple eaves returns.

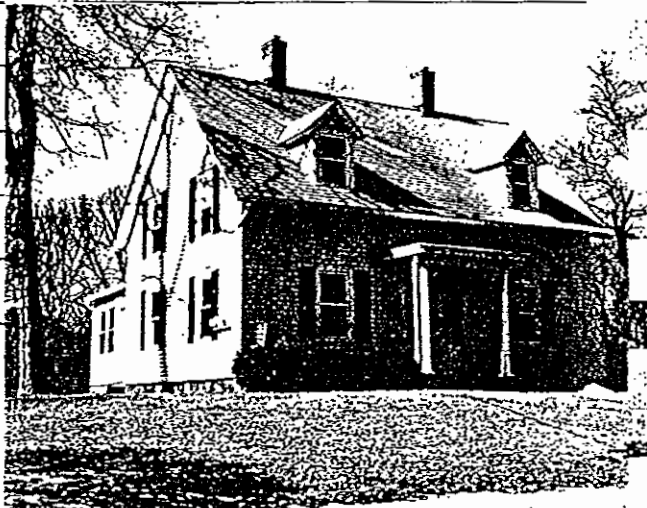
11. NUMBER OF STORIES 1-1/2		APPROXIMATE DIMENSIONS 32' x 22'	
12. CONDITION (Structural)			
<input type="checkbox"/> Excellent	<input checked="" type="checkbox"/> Good	<input type="checkbox"/> Fair	<input type="checkbox"/> Deteriorated
(Exterior)		<input type="checkbox"/> Excellent	<input checked="" type="checkbox"/> Good <input type="checkbox"/> Fair <input type="checkbox"/> Deteriorated

158-160 Oak Grove Street is an unusual 1-1/2-story Cape Cod-style two-family frame residence with a gable roof, oriented with the long elevation to the street. The structure rests on a brick foundation and is sheathed with replacement vinyl siding. The building incorporates twin central entries and a small entry porch with Tuscan columns. Window sash is of 1/1 configuration arranged in a three-bay facade. Architectural features include two small gable dormers, one-story gabled ell, and twin offset chimneys.
