# HISTORIC RESOURCES INVENTORY

## BUILDINGS AND STRUCTURES

STATE OF CONNECTICUT  
**CONNECTICUT HISTORICAL COMMISSION**  
 59 SOUTH PROSPECT STREET, HARTFORD, CONNECTICUT 06106  
 (203) 566-3005

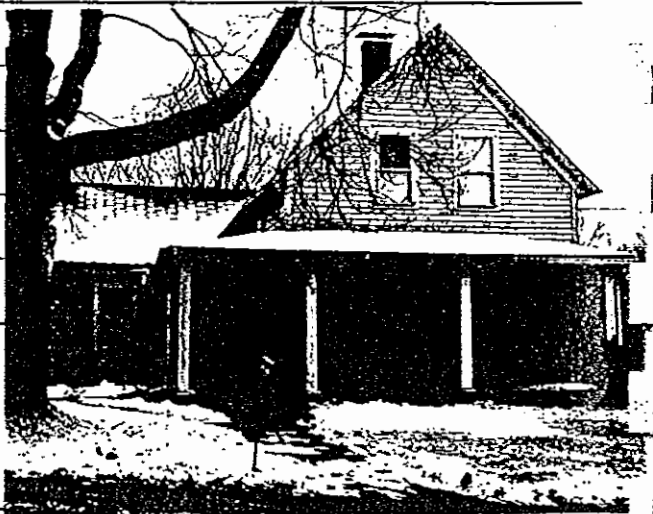
148 South Main Street is a simple 1-1/2-story vernacular nineteenth-century frame cottage with a gable roof, oriented with the gable end to the street. The structure rests on a stone foundation and is sheathed with clapboards. The building incorporates an offset entry and wraparound porch with square columns. Window sash is of 1/1 configuration in a two bay facade. Architectural features include scroll-sawn bracketed eaves and a one-story gabled wing at the left/rear.

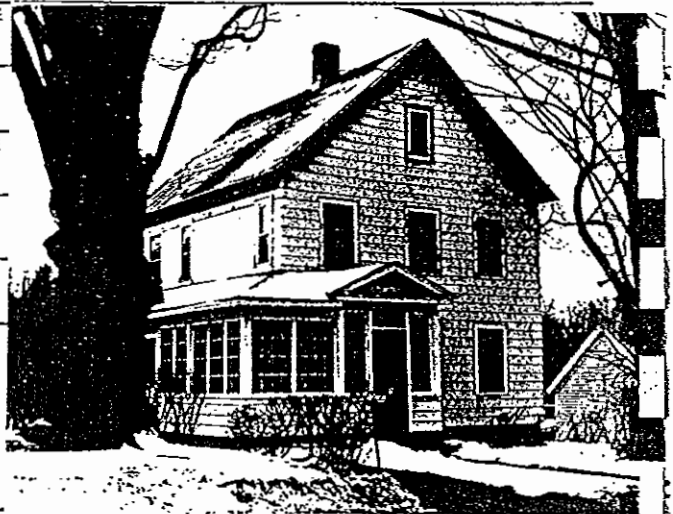
154 South Main Street is a simple two-story vernacular frame residence with a gable roof, oriented with the gable end to the street. The structure rests on a brick foundation and is sheathed with replacement aluminum siding. The building incorporates an offset entry (front/left) and wraparound enclosed entry porch with gabled peak. Window sash is of 2/2 configuration in a three-bay facade. Architectural features include a small central chimney and simple rectangular sash in the gable peak.

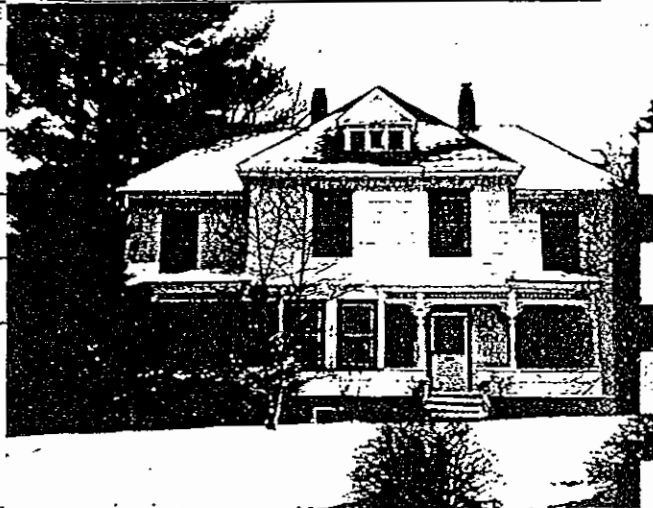
155 South Main Street is a very substantial two-story Queen Anne-style two-family frame residence with a complex hip roof, oriented with the long elevation to the street. The structure rests on a brick foundation and is sheathed with replacement asbestos siding. The building incorporates offset entries and angled entry porches with turned columns, sawn brackets, and spindle frieze. Window sash is of 1/1 configuration. Architectural features include a gabled dormer in the street elevation, wide bracketed eaves, two-story hip-roofed wings on the right and left with small hip dormers, two-story hip-roofed pavilion/tower in the center of the street elevation, and modest molded window entablatures. c.

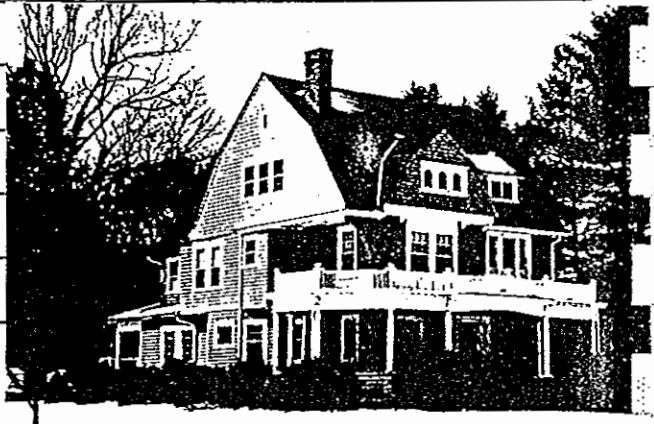
202 South Main Street is a wonderful 2-1/2-story Colonial Revival/Shingle-style frame residence with a gambrel roof, oriented with the long elevation to the street. The structure rests on a brick foundation and is sheathed with wood shingles. The building incorporates a central entry with sidelights and molded surround and an elaborate wraparound porch with solid balustrade, Tuscan half-columns, pedimented entry gable, surmounted by a balustraded sunporch. Window sash is of 6/1 configuration. Architectural features include a gambrel dormer with Palladian window in the street elevation, external chimney on the left, large cutaway corner at the left/front, two-story gabled wing in the rear, two-story bay window on the right, and an attractive oriel window, also on the right.

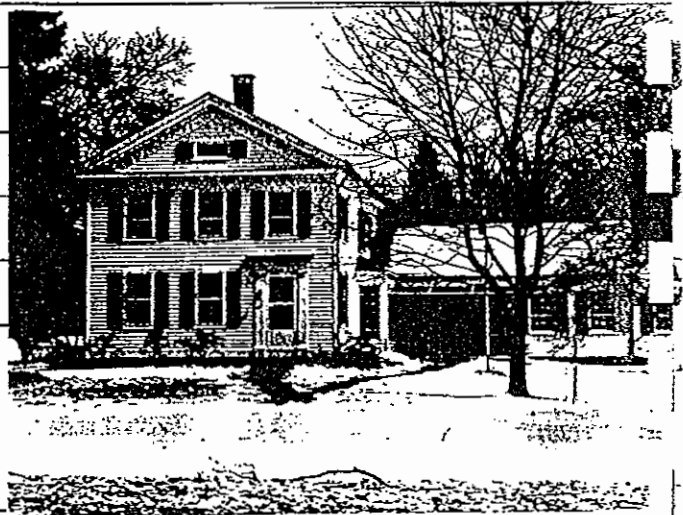
211 South Main Street is a lovely two-story Greek Revival-style frame residence with a gable roof, oriented with the gable end to the street. The structure rests on a stone foundation and is sheathed with clapboards. The building incorporates an offset entry (front/right) and strongly molded pilaster-and-lintel surround. Window sash is of 8/8 and 8/12 configuration arranged in a three-bay facade. Architectural features include wide frieze and rake, molded eaves, single-story gabled ell in the rear, a 1-1/2-story gabled wing on the right, and a pedimented gable with horizontal window in the peak containing later Victorian glazing.

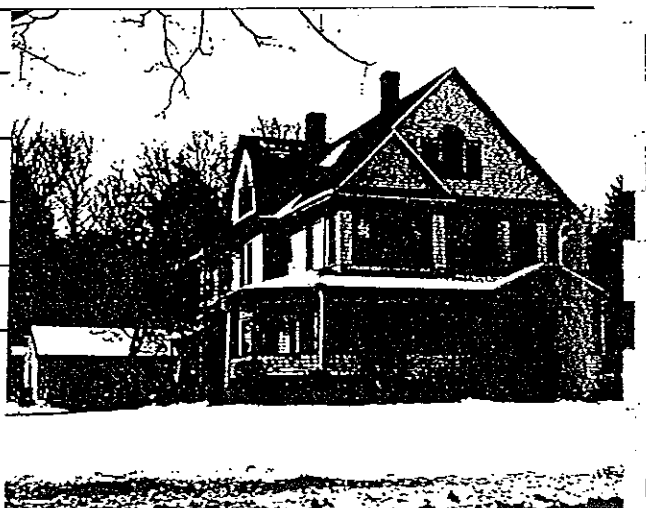
214 South Main Street is a wonderful 2-1/2-story Colonial Revival-style frame residence with a gable roof, oriented with the gable end to the street. The structure rests on a brick foundation and is sheathed with wood shingles. The building incorporates an offset entry with sidelights and wide pilaster-and-lintel surround at front/left and an elaborate wraparound porch with shingled balustrade, paired Tuscan half-columns, bracketed eaves, and gabled entry peak with elaborate tympanum ornament. Window sash is of 1/1 configuration. Architectural features include a gable dormer with pent eave at the front/left, a large gambrel dormer with Palladian window on the left and a similar dormer/window on the right, and a Palladian window in the peak of the street-facing gable.

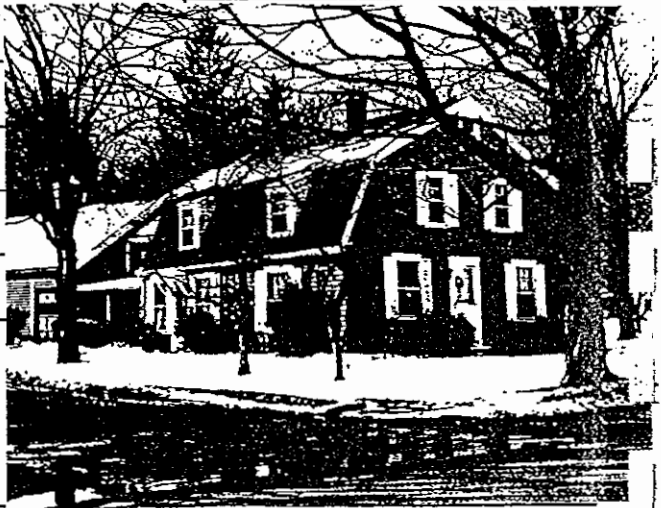
PHOTOGRAPHER	Geoffrey Rossano	DATE	January 1998
VIEW	NW	NEGATIVE ON FILE	CHC

234 South Main Street is an attractive 1-1/2-story Cape Cod-style dwelling with a gambrel roof, oriented with the long elevation facing south. The structure rests on a stone foundation and is sheathed with wooden shingles. The building incorporates entires on both the long and end elevations, both with plain surrounds. Window sash is of 6/6 configuration. Architectural features include a broad gambrel roof, central chimney, two small shed dormers on the south-facing elevation, a two-story gabled wing on the left, and a connected four-bay garage attached to the side wing.

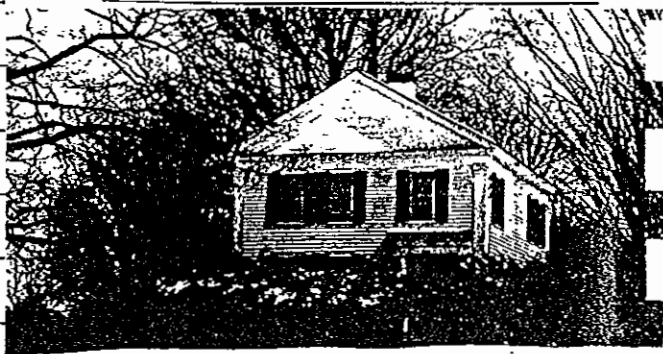
333 South Main Street is a handsome two-story Greek Revival-style frame residence with a gable roof, oriented with the gable end to the street. The structure rests on a stone foundation and is sheathed with clapboards. The building incorporates an offset entry (front/right) with sidelights and robust pilaster-and-lintel surround. Window sash is of 6/6 configuration arranged in a three-bay facade. Architectural features include a pedimented gable with flushboard siding, wide frieze, molded eaves, central chimney, wide corner pilasters, and one-story gabled ell in the rear.

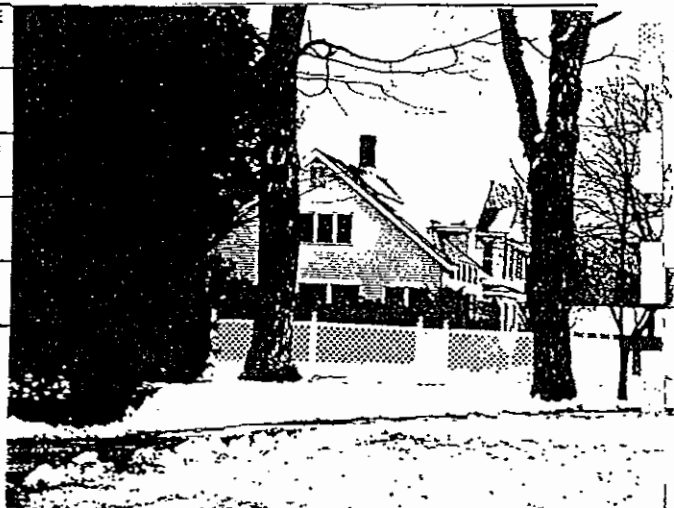
357 South Main Street is a rambling and much-expanded two-story vernacular frame dwelling with a gable roof. The structure rests on a brick foundation and incorporates a recessed entry on the south elevation. Window sash is of mixed configuration. The heart of the building appears to be a two-story block measuring 16 x 28 and oriented with the long elevation to South Main Street, exhibiting a two-story bay window on the south facade. There is also a two-story gabled ell in the rear with a gable dormer, 1-1/2-story projecting gabled wing in the street elevation, as well as additional gabled and hipped additions and porches.

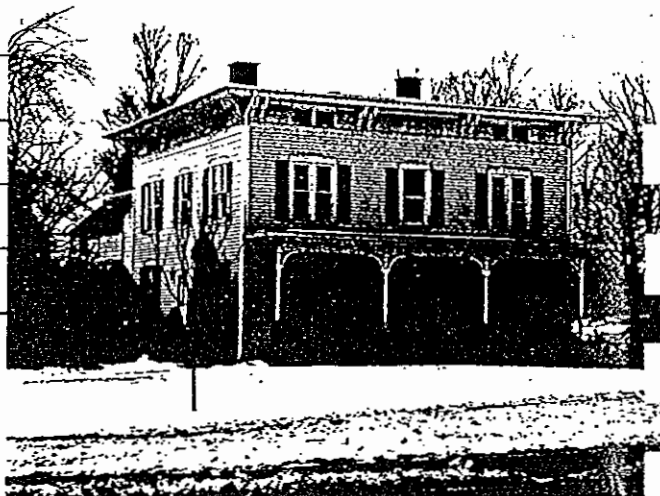
600 South Main Street is a handsome two-story Italianate-style frame residence with a shallow hip roof. The building rests on a stone foundation and is sheathed with replacement vinyl siding. The building incorporates a central entry with round-arched door panels, sidelights, and rectangular transom and a full-width porch with bracketed eaves, turned columns, and bracketed spandrels. Window sash is of paired 4/4 configuration arranged in a three-bay facade. Architectural features include elaborately bracketed eaves, a two-story wing in the rear, and small frieze windows beneath the broad eaves at the attic level.
