Manchester, Connecticut
West Side Neighborhood Cultural Resource Survey

May 1995

Sponsored by the Town Of Manchester

Connecticut Historical Commission

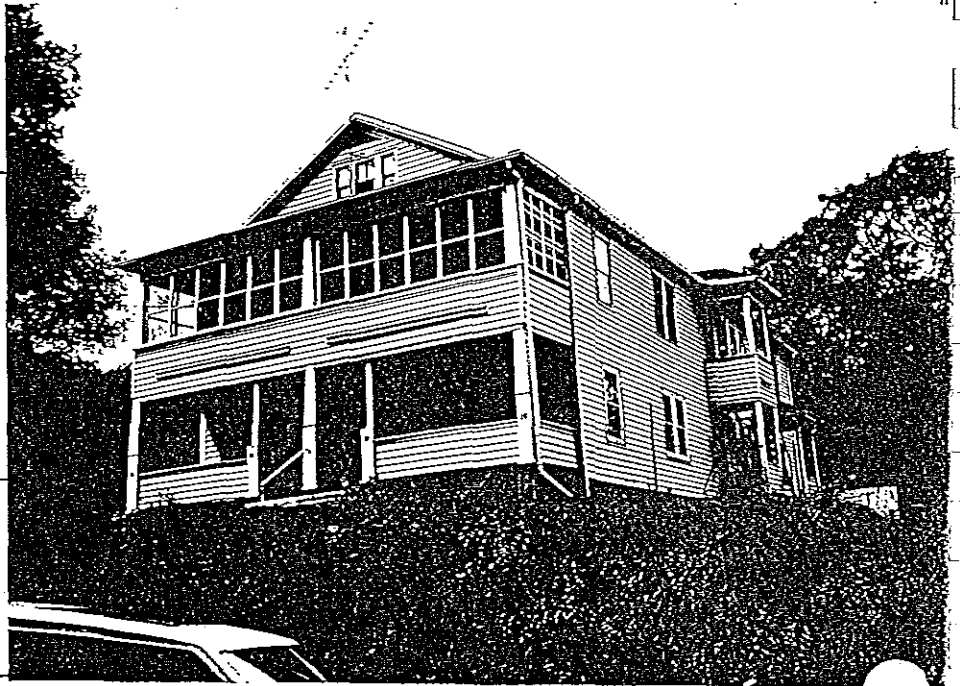
11. NUMBER OF STORIES 2 1/2		APPROXIMATE DIMENSIONS	
12. CONDITION (Structural) <input type="checkbox"/> Excellent <input checked="" type="checkbox"/> Good <input type="checkbox"/> Fair <input type="checkbox"/> Deteriorated		(Exterior) <input type="checkbox"/> Excellent <input checked="" type="checkbox"/> Good <input type="checkbox"/> Fair <input type="checkbox"/> Deteriorated

This gable-roofed, two-and-one-half-story, multi-family house is approximately three-bays across and rests on a brick foundation that has been resurfaced with stucco. Although it has been aluminum sided, one can still see the battered porch supports at the ground floor and second story porches. Both porches have aluminum-sided skirts, and the second story porch has been enclosed with 1/1 sash. Fenestration all the way around is 2/2 sash and the doors on t' main facade retain the original paneled entry doors with glass storms. On the side facades are two-story, hip-roofed porches that serve as rear apartment entrances.

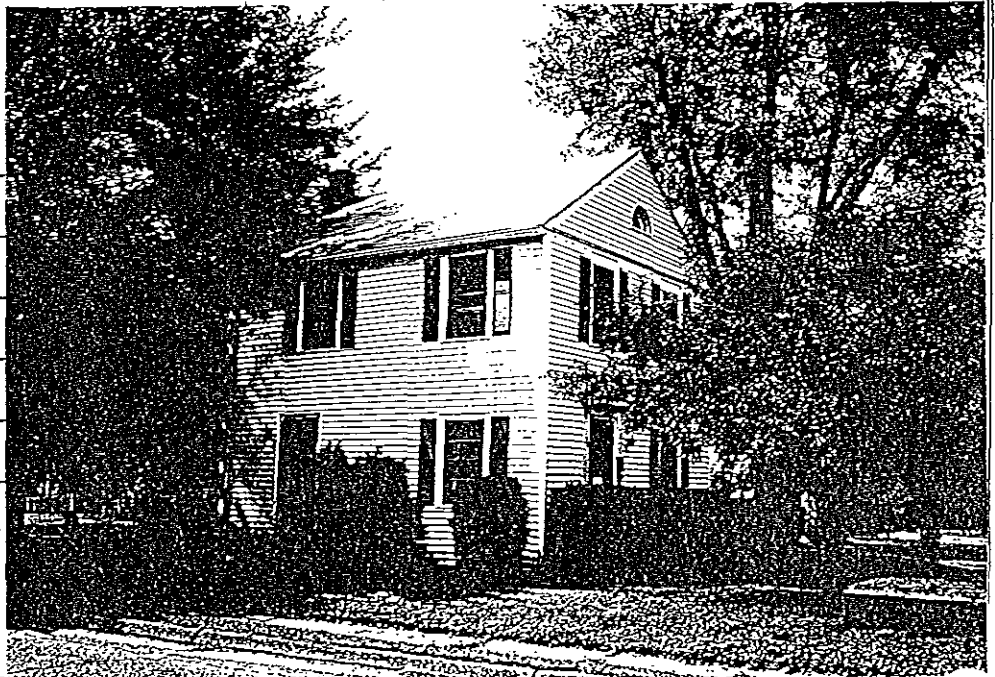
11. NUMBER OF STORIES 2 1/2		APPROXIMATE DIMENSIONS 20 x 22	
12. CONDITION (Structural) <input type="checkbox"/> Excellent <input checked="" type="checkbox"/> Good <input type="checkbox"/> Fair <input type="checkbox"/> Deteriorated		(Exterior) <input type="checkbox"/> Excellent <input checked="" type="checkbox"/> Good <input type="checkbox"/> Fair <input type="checkbox"/> Deteriorated

This is a two-bay, gable-roofed vernacular house that may originally have been Greek Revival in style. The house rests on a stucco-surfaced foundation and has been resurfaced with vinyl siding. It does, however, retain a lunette window in the gable end and 6/6 sash throughout. It has a paneled entry door located at the south corner of the elevation; and a paneled side door on the south side elevation. The heads of the second story windows run up into the eaves; a small chimney is found to the rear.

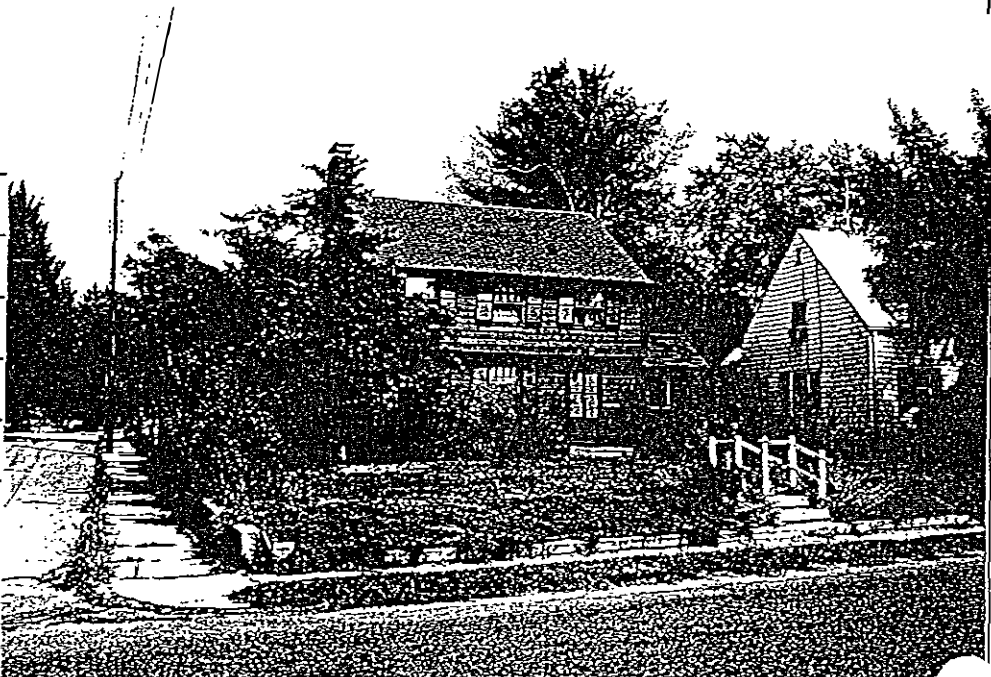
11. NUMBER OF STORIES 2		APPROXIMATE DIMENSIONS 26 x 25	
12. CONDITION (Structural)		(Exterior)	
<input type="checkbox"/> Excellent <input checked="" type="checkbox"/> Good <input type="checkbox"/> Fair <input type="checkbox"/> Deteriorated		<input type="checkbox"/> Excellent <input checked="" type="checkbox"/> Good <input type="checkbox"/> Fair <input type="checkbox"/> Deteriorated

This is a three-bay, two-story, gable-roofed, clapboard-surfaced, Garrison Colonial Revival dwelling. The side entry, located at the south corner is articulated as a louvered door with long latch hinges. It is flanked by two 8/8 windows to the north. The second story, which overhangs with corner pendants in a Garrison mode has three 8/8 windows. A one-story, gabled wing is found to the south and a brick chimney pierces the gable end on the north side elevation. At the ground floor, the chimney is flanked by diamond-paned casement sash, above which are 6/6 windows. A shed-roofed porch is found at the rear. A detached, two-bay, salt box garage is found on High Street.

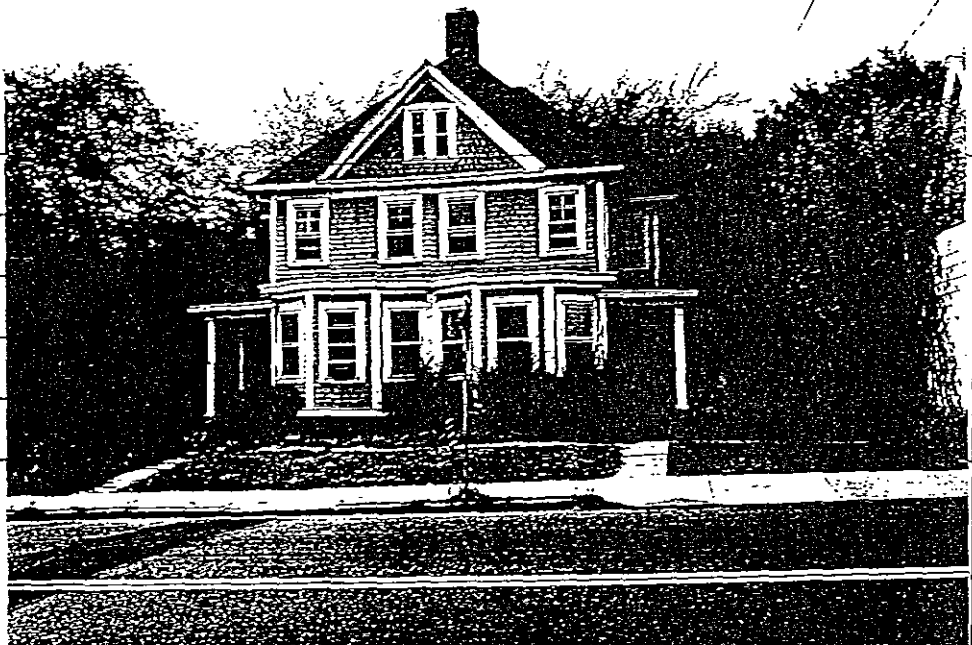
11. NUMBER OF STORIES 2 1/5		APPROXIMATE DIMENSIONS 33 x 45	
12. CONDITION (Structural)		(Exterior)	
<input type="checkbox"/> Excellent <input checked="" type="checkbox"/> Good <input type="checkbox"/> Fair <input type="checkbox"/> Deteriorated		<input type="checkbox"/> Excellent <input checked="" type="checkbox"/> Good <input type="checkbox"/> Fair <input type="checkbox"/> Deteriorated

Built about 1895 on land owned by Trotter or the Cheney's, this house generally conforms to one of the standard two-family house types found in Manchester. It follows the hipped-roof type with individual side porches, while two bay windows replace the typical central porch. It has retained its essential massing, siding and most of its porch details.

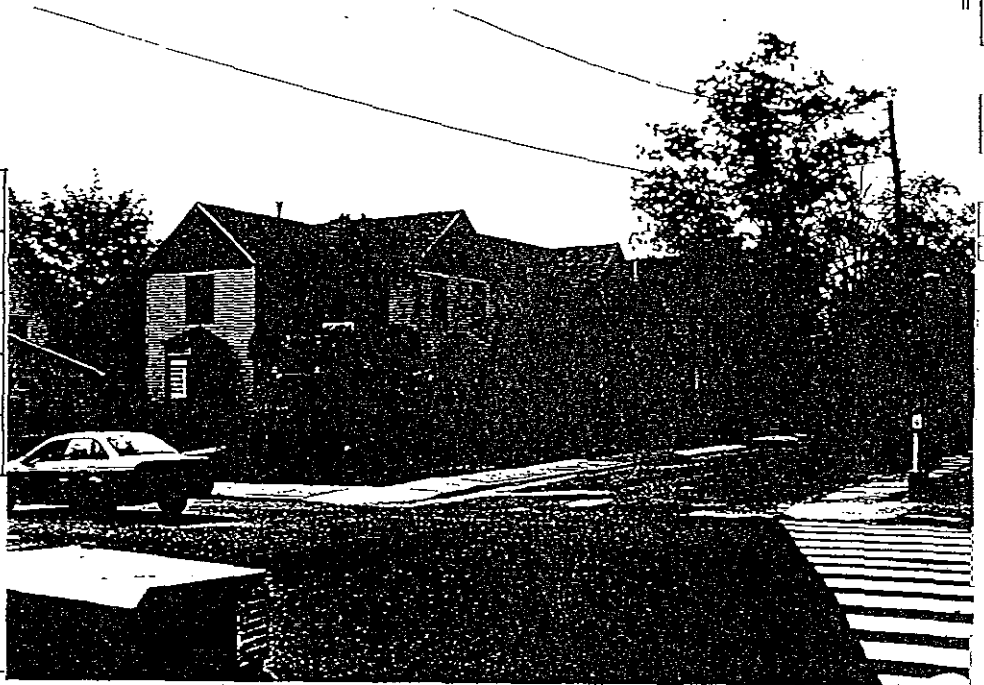
11. NUMBER OF STORIES 2 1/2		APPROXIMATE DIMENSIONS 46 x 22	
12. CONDITION <i>(Structural)</i>		<i>(Exterior)</i>	
<input type="checkbox"/> Excellent <input checked="" type="checkbox"/> Good <input type="checkbox"/> Fair <input type="checkbox"/> Deteriorated		<input type="checkbox"/> Excellent <input checked="" type="checkbox"/> Good <input type="checkbox"/> Fair <input type="checkbox"/> Deteriorated

This two-and-one-half-story, cross-gable-roofed, Queen Anne structure rests on a brick foundation that has been resurfaced with aluminum siding (although wood shingles, and original arched windows have been preserved in the gable ends). Multi-bayed, the house extends down Orchard Street. Most of the 2/2 windows of the second story have been preserved. At the ground floor is a projecting bay window and a filled-in porch at the Center Street elevation. On the Orchard Street elevation, a three-bay arched porch and two projecting bays have been preserved. On the western elevation, there is a small, projecting bay.

This house was built about 1900 and conforms to a relatively old multi family dwelling form found in Manchester. It follows the projecting side pavilion plan type with a two bay central porch that houses a pair of entry doors. Virtually all of the original details, with the exception of some siding and a small addition, have been preserved and it is an excellent example of its type.

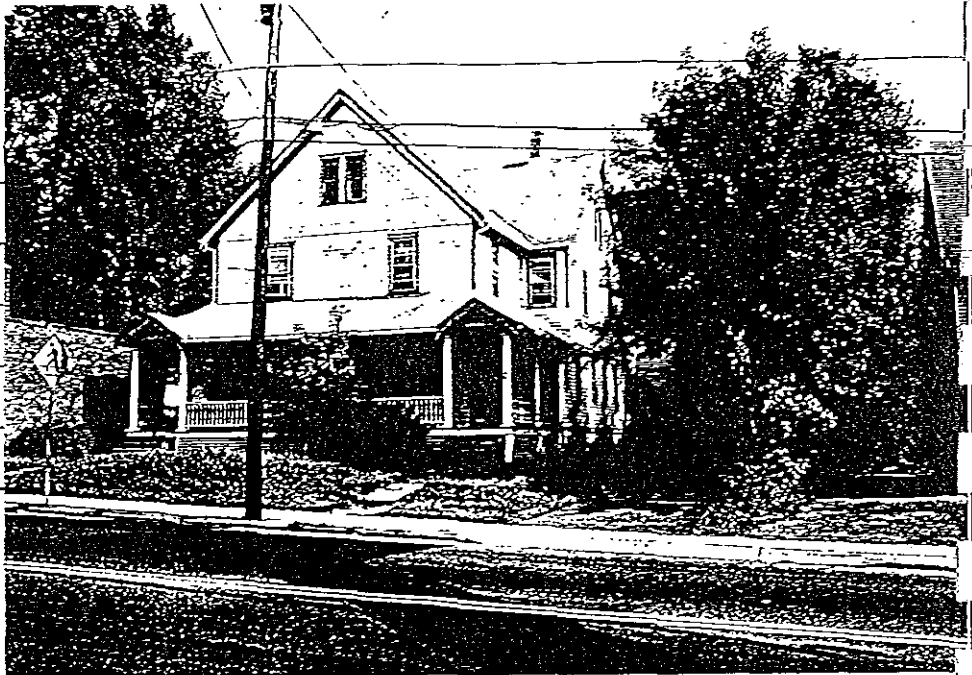
11. NUMBER OF STORIES 2 1/2		APPROXIMATE DIMENSIONS 36 x 45	
12. CONDITION (Structural) <input type="checkbox"/> Excellent <input checked="" type="checkbox"/> Good <input type="checkbox"/> Fair <input type="checkbox"/> Deteriorated		(Exterior) <input type="checkbox"/> Excellent <input checked="" type="checkbox"/> Good <input type="checkbox"/> Fair <input type="checkbox"/> Deteriorated

This is a two-and-one-half-story, cross-gable-roofed, "T"-plan double house. Its foundation has been resurfaced with stucco, and the first two stories are surfaced with clapboards that terminate in cornerboards. The gable ends are articulated as open-bed pediments and are surfaced with alternating courses of three rows of imbricated and plain shingles. The gable end contains paired windows with Shavian sash. The second story windows have been replaced. The ground floor is sheltered by a hip-roofed porch that wraps around three elevations. The recessed side entries are noted by projecting gabled pediments with prominent barge boards and reverse imbricated shingling in the tympanum. The porch is supported by Doric columns united by a turned spindled balustrade. The paired windows of the ground floor have paired 1/1 sash; the western entry has retained its paneled door with glazing, but the eastern entry has a modern, Colonial Revival door. There is a porch at the rear of the property.

Built about 1890 and probably by the Cheney's, this house generally conforms to one of the standard house types found in Manchester. T-shaped in plan, it also has a projecting central gable and three bay porch with two side porches providing entry to the building. Virtually all of the original details have been preserved and it is an excellent example of its type.

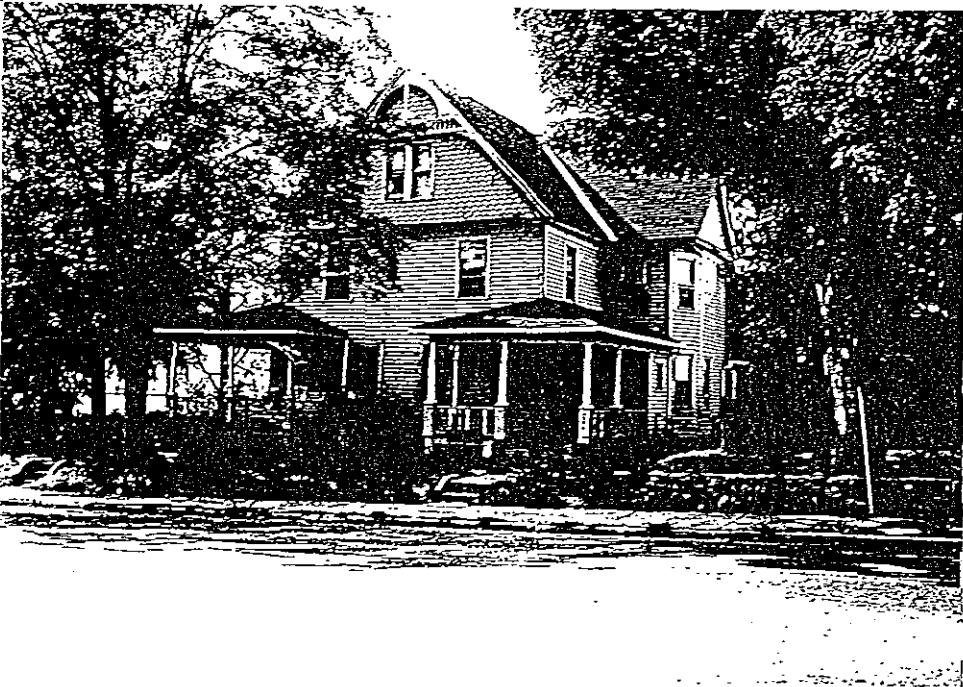
11. NUMBER OF STORIES 2 1/2		APPROXIMATE DIMENSIONS 37 x 40	
12. CONDITION (Structural) <input type="checkbox"/> Excellent <input checked="" type="checkbox"/> Good <input type="checkbox"/> Fair <input type="checkbox"/> Deteriorated		<i>(Exterior)</i> <input type="checkbox"/> Excellent <input checked="" type="checkbox"/> Good <input type="checkbox"/> Fair <input type="checkbox"/> Deteriorated

17. OTHER NOTABLE FEATURES OF BUILDING OR SITE INTERIOR AND EXTERIOR
 This two-and-one-half-story, cross-gable-roofed, "T"-plan double house is executed in the Queen Anne Style. The building rests on a brick foundation and is surfaced with clapboards at the first and second stories and shingles in the gable ends. Approximately four bays wide, each street corner of the ground floor is distinguished by paired, hip-roofed porches that wrap around to the side elevations. The porches are supported by Tuscan colonets that rest on paneled bases united by a modern spindled balustrade. Most of the windows have been replaced with the exception of a Shavian window perpendicular to each entry. The gable ends project slightly and the front gable end is articulated as an open-bed pediment with paired sash and an elaborate peak ornament with a spooled valance and semicircular cutout. The cross-gable is articulated as a two-story bow, with the closed-bed-pedimented gable end supported by simple curving brackets that meet in pendant finials. There is a Queen Anne porch at the rear that is supported by turned posts and cutwork foliate brackets.

19. HISTORICAL OR ARCHITECTURAL IMPORTANCE
 Built about 1890, this house generally conforms to one of the standard house types found in Manchester. T-shaped in plan, it also has a projecting central and separate side porches. Virtually all of the original details have been preserved and it is an excellent example of its type as described in section 17.

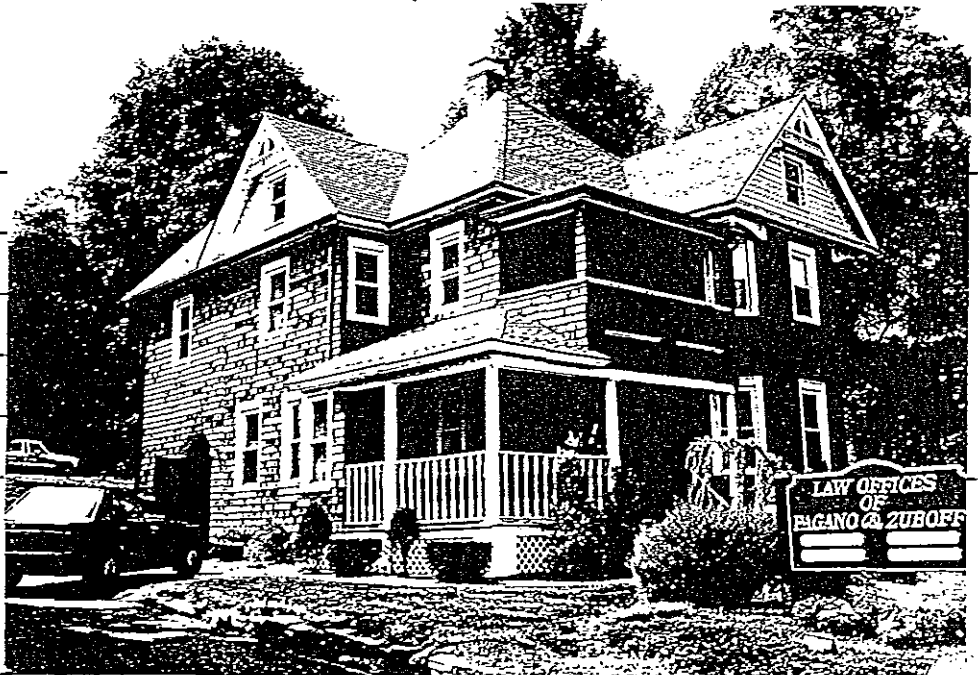
This two-and-one-half-story, hip-and-cross-gable-roofed multi-family Colonial Revival-style dwelling is three-bays across and rests on a stucco-surfaced foundation. The ground floor has been resurfaced with aluminum siding and the second floor is surfaced with composition shingles, as are the gable ends. Paired, two-and-one-half-story, gable-roofed pavilions project from the building's corners. These are articulated as bows at the first and second story; above which the gable ends are articulated as open-bed pediments with a single double hung window that are supported at the eaves by curving corner brackets. The projecting pavilions flank a central, two-story, two-bay Tuscan porch. The porches have stick balustrades. At both stories, the central entries are flanked by single 3/4 height sidelights that rest on paneled bases. Most of the windows have been replaced. Recessed, flanking wings provide access to the upper floors.

This building appears to have been built as infill by the Cheney's for additional wartime housing in 1917. The large hipped roof and double porches are similar to those found on some house sin Knox street, also Cheney supported housing. Many of the original details have been preserved and it is an excellent example of its type as described in section 17.-

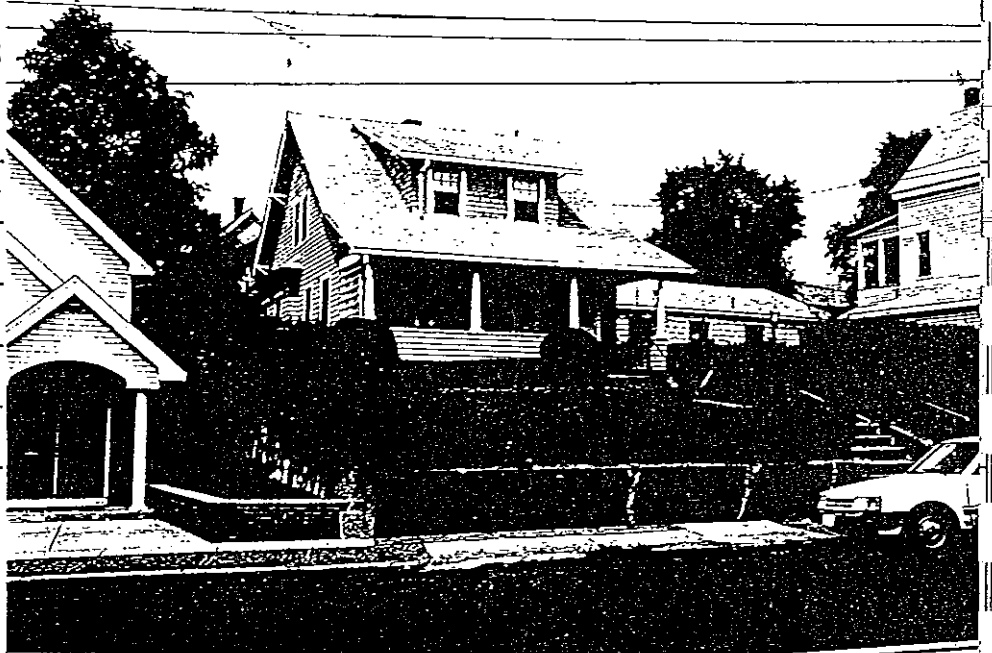
This is a two-and-one-half-story, three-bay, gable-roofed Colonial Revival structure. The house rests on a brick foundation and the ground floor is surfaced with clapboard, the upper stories with wooden shingles. The gable end is articulated as an open-bed pediment with a prominent eave and narrow raking friezeband, and a single window. At the ground floor is a two-bay, Tuscan columned porch; the columns rest on a shingled skirt. At the second floor there is a smaller, one-bay porch of the same design. At the juncture of the first and second floors there is a slight splaying to form a skirt course. On the eastern elevation is a two-bay entry porch with turned spindled balusters and Tuscan columns.

Built about 1912, this house is typical of many found on the northwestern fringe of the survey area. It is a typical form for a Colonial Revival style two-family house in this area, and is reasonably well preserved.

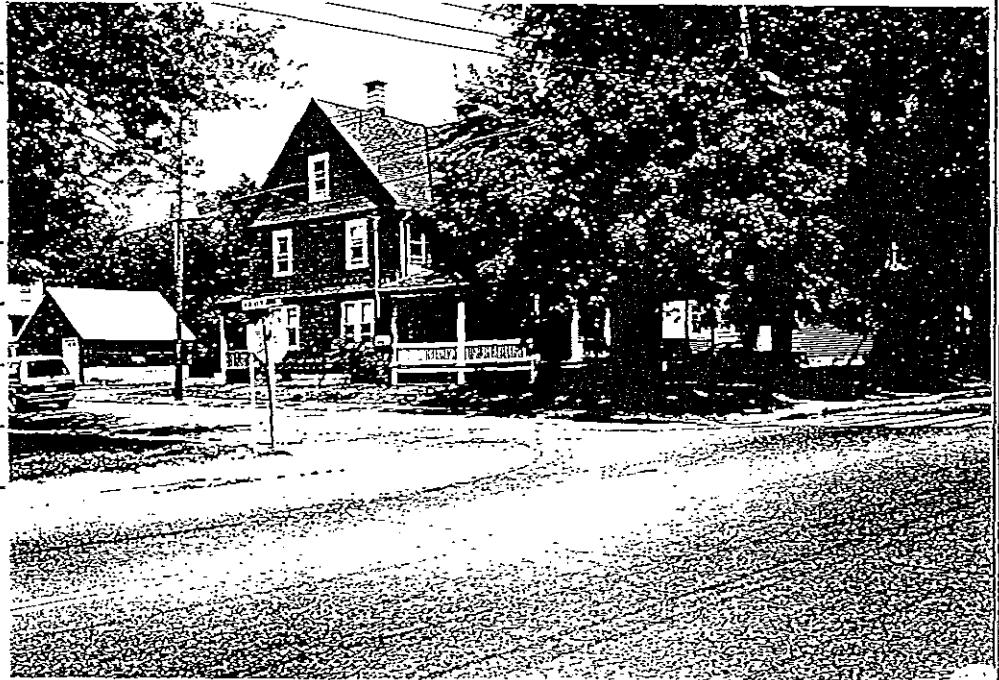
This is a two-and-one-half-story, cross-gable-roofed, "T"-plan double house articulated in a Colonial Revival style. The house rests on a molded concrete foundation that has been made to look rusticated. Paired two-bay, hip-roofed entry porches, supported by Tuscan columns and united by a stick balustrade, wrap around the sides of the building. Gables denote the entry. Windows have 2/2 sash. The building has been resurfaced with asbestos shingles, but one can still see the apron skirtings that denote the second story and the bases of the gable ends. The gable ends are articulated as open-bed pediments with strong eaves and prominent returns. The forward gable end has paired sash; single windows are found in the side gable ends.

Built about 1900, this house is a typical T-plan gable-roof type with individual side porches. It further should be noted for its flared shingles at each floor level. Despite siding it has retained its essential massing and decorative elements.

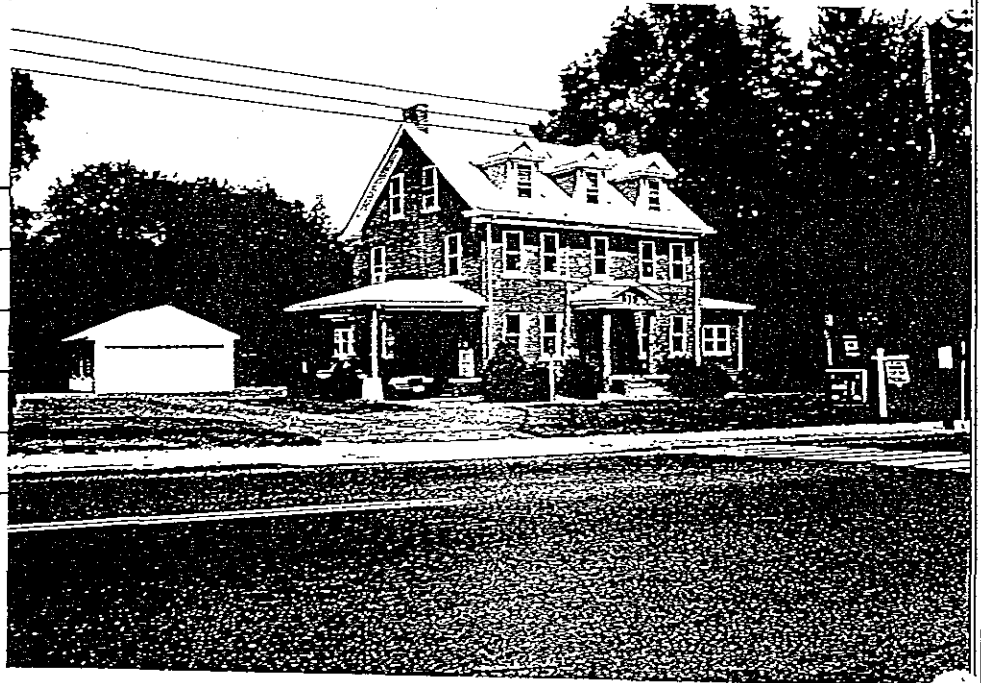
This two-and-one-half-story, gable-roofed, brick, five-bay, Colonial Revival building rests on a brick foundation. The central entry is sheltered by a one-bay, gable-roofed portico supported by brick pillars. Its gable end is articulated as an open-bed pediment with strong returns that enframe the building's address. The entry itself consists of a paneled door flanked by wide, half-height sidelights that rest on paneled bases, all topped by a horizontal transom. Each of the 8/1 windows rest on a stone sill, and is topped by brick jack arches. Three gabled dormers that have been resurfaced with aluminum siding project from the roof. They are articulated as closed-bed pediments that top single, 6/6 windows. A one-story, hip-roofed addition is found to the east. On its western side is a hip-roofed, *porte cochere* supported by simple brick pillars. A one-story addition has been added to the rear as well. A modern, gable-roofed garage is found at the rear of the property. The building has been sandblasted, affecting the texture and mortar joints of the brick.

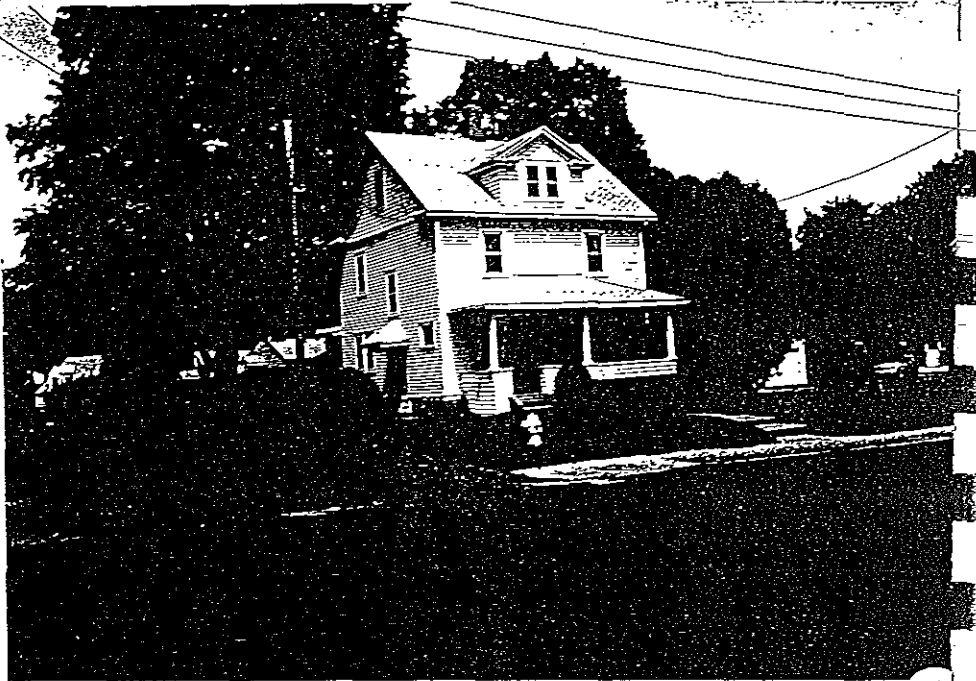
This is a two-bay, two-and-one-half-story, gable-roofed Colonial Revival structure that rests on a stucco surfaced foundation and is surfaced with clapboards at the first two stories and shingled in the gable ends. The building has a two-bay, hip-roofed, Tuscan columned entry porch, with Tuscan colonetts resting on a skirted balustrade. The glass and paneled entry door is to the west, flanked by a triple window to the east. From the roof, a gabled dormer that articulated as an open-bed pediment with strong returns, enframes paired windows. The side gables are articulated as open-bed pediments with strong returns and contain single windows; their bases splay out slightly to form a splayed skirt. A hip-roofed portico shelters a side entry, and to the rear a Tuscan-columned porch is glass enclosed. Fenestration throughout consists of double-hung sash with simple surrounds.

This simple Colonial Revival style house is typical of those found in the western end of the survey area, and may be part of the area Ralph Cheney developed in the 1920s. This house is architecturally interesting for its simple and unassuming forms that were so common in this type of housing between 1910 and 1930.

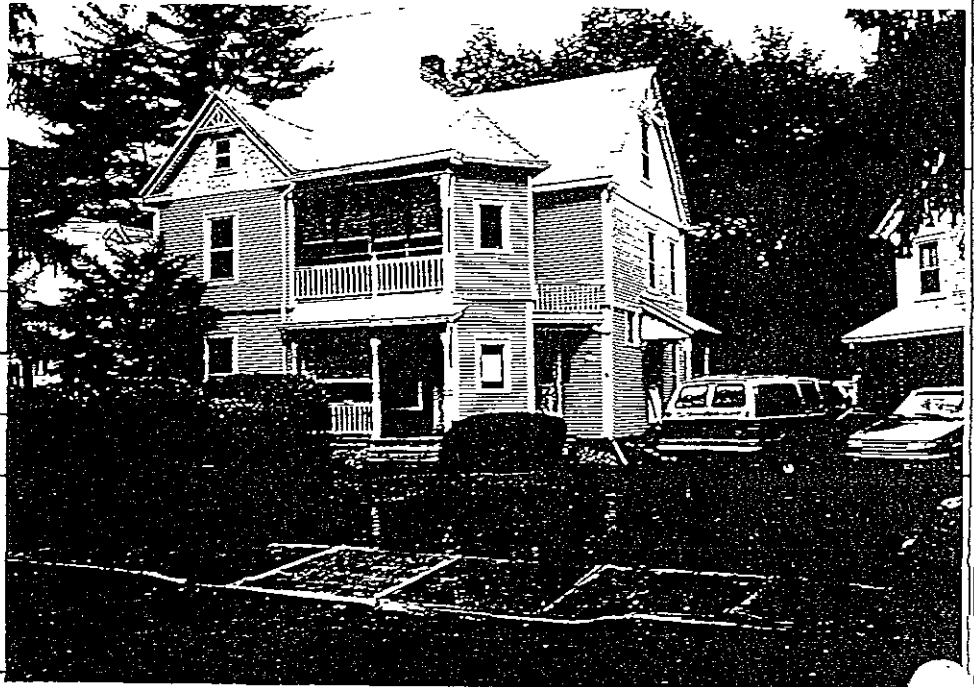
This house is located on the northwest side of Chestnut Street, and appears to have been built as a pair with 32 Linden Street, immediately to the east. It is found in an urban residential neighborhood, quite proximate to Center Park.

This asymmetrically-shaped, two-and-one-half-story, cross-gable-on-hip-roofed, Queen Anne building is a pair with 32 Linden Street immediately to its east. The building rests on a brick foundation and has been resurfaced with vinyl siding. It has, however, retained its porches which are supported by turned posts with cutwork brackets and elaborate, spooled valanced and spindled balustrades. At the second floor level, the porch is enclosed with screens. These porches are recessed between a projecting gabled pavilion to the west and an angled, one-bay, projecting hip-roofed pavilion to the east. The fenestration is 2/2. The gable ends still are surfaced with imbricated and clipped shingles and contain elaborate peak ornamentation in a Kingpost motif. A side porch, that matches the main porch in shape and materials, is located on the northeast elevation.

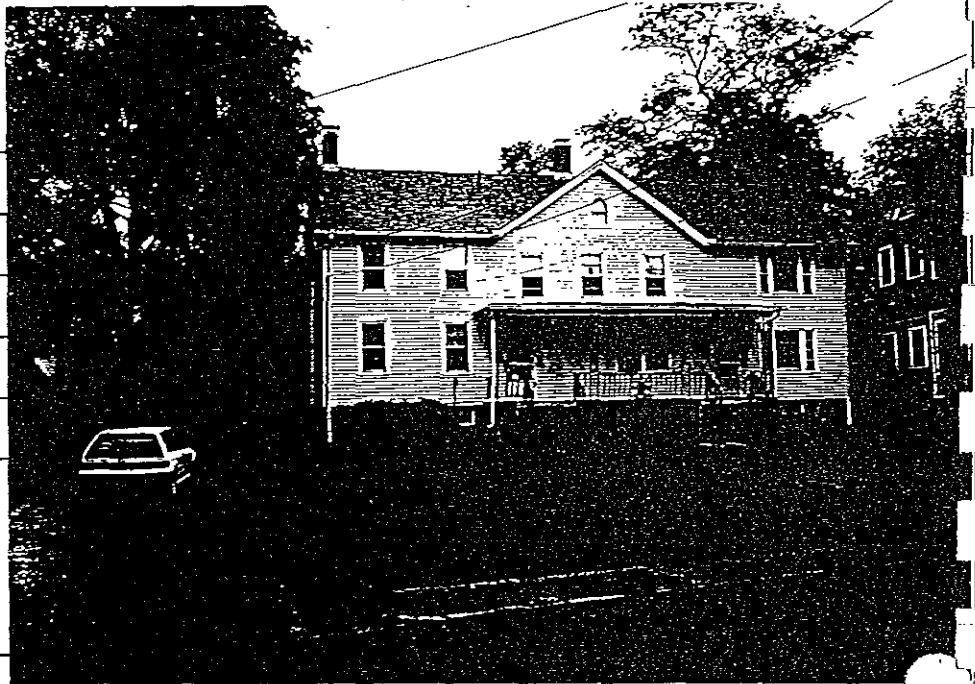
This large, cross-gable-roofed, rectangular plan double house is executed in the Italianate style and rests on a brick foundation. Although most of the fenestration has been altered, and the building's siding has been replaced with vinyl, it retains its basic Italianate form, characteristic of Cheney-related, multi-family, development in Manchester. The gable end contains an arched window. A three-bay, flat-roofed porch, extending across part of the facade, has modern wrought-iron elements.

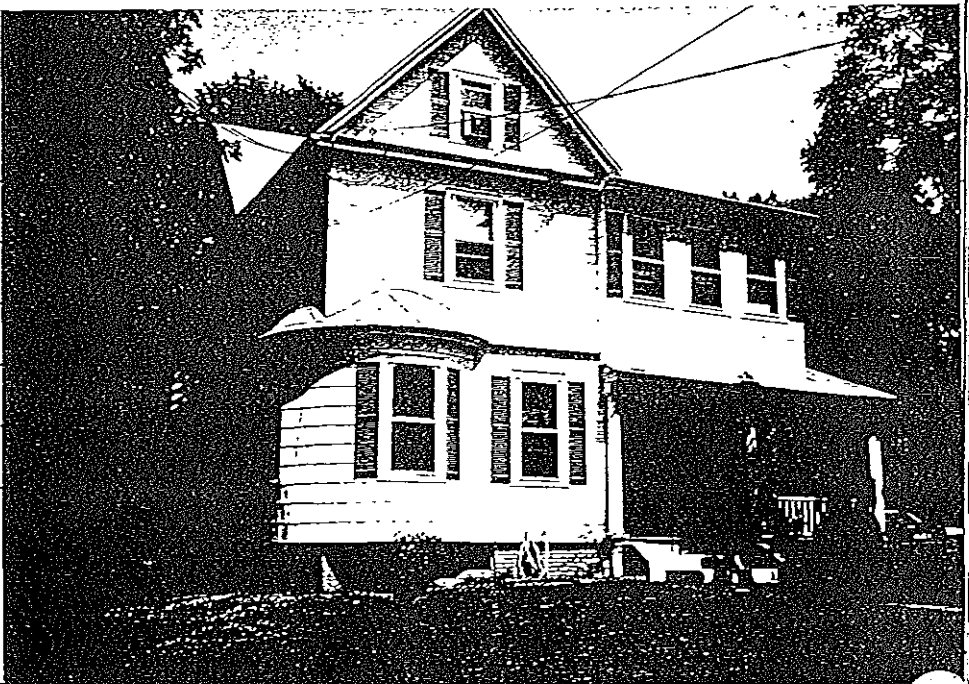
11. NUMBER OF STORIES 2 1/2		APPROXIMATE DIMENSIONS 32 x 30	
12. CONDITION (Structural) <input type="checkbox"/> Excellent <input checked="" type="checkbox"/> Good <input type="checkbox"/> Fair <input type="checkbox"/> Deteriorated		(Exterior) <input type="checkbox"/> Excellent <input checked="" type="checkbox"/> Good <input type="checkbox"/> Fair <input type="checkbox"/> Deteriorated

This is a three-bay, two-and-one-half-story, cross-gable, hip-roofed, Queen Anne residence. The building rests on a brick foundation and has been resurfaced with asbestos shingles. A Tuscan columned porch with a stick balustrade wraps around to the east side elevation. The southwest corner of the building has a one-story, circular bow, and the cross-gable is articulated as a closed-bed pediment, with deep eaves and a single window. There is another projecting bow on the western side elevation. Most of the fenestration has been replaced with modern double-hung sash. There is a modern, two-story porch addition at the rear of the house.

This house is one of a series of houses built by the Cheney's and sold to their employees about 1900. This house was sold to Pehr Brink in 1901 (36/13). Architecturally it should be noted in particular for its corner bow and gable ornament.

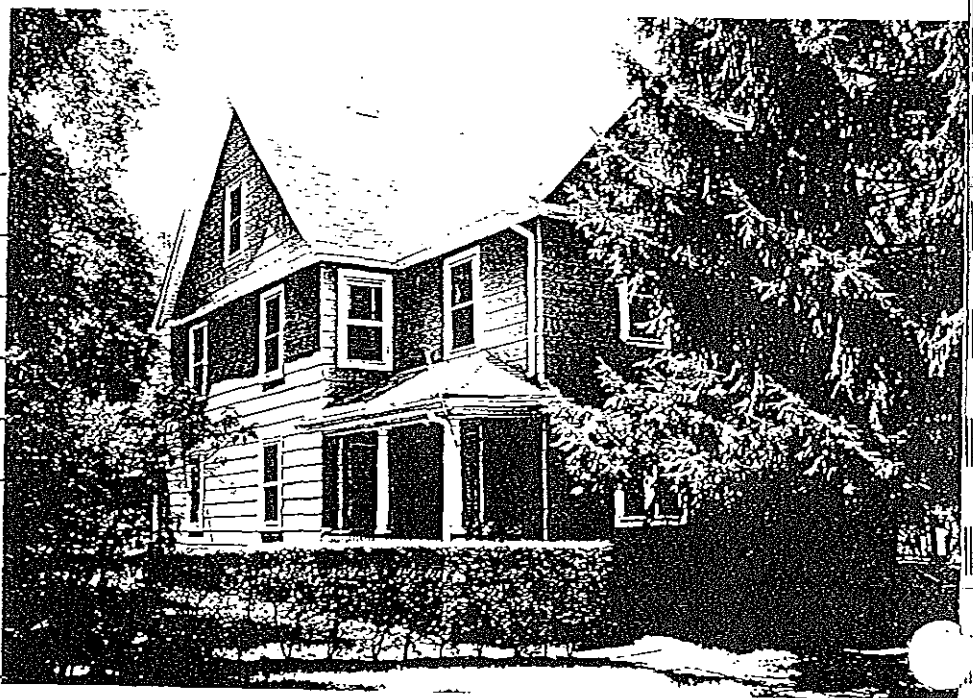
11. NUMBER OF STORIES 2 1/2		APPROXIMATE DIMENSIONS 27 x 37	
12. CONDITION <i>(Structural)</i>		<i>(Exterior)</i>	
<input type="checkbox"/> Excellent <input checked="" type="checkbox"/> Good <input type="checkbox"/> Fair <input type="checkbox"/> Deteriorated		<input type="checkbox"/> Excellent <input checked="" type="checkbox"/> Good <input type="checkbox"/> Fair <input type="checkbox"/> Deteriorated

This "T"-Plan, four-bay, cross-gable-roofed, Queen Anne/Colonial Revival double house rests on a brick foundation and is surfaced with asbestos shingles. The ground floor is articulated by two sets of paired double-hung windows, flanked by one-bay-deep, shed-roofed side porches that are supported by Tuscan columns with entasis that rest on square bases that are united by a spindled balustrade. The entries are elaborate paneled doors, articulated as paired vertical panels below a horizontal panel, below a square pane, topped by small square panels with 12-light storm doors. The eastern porch has two entries. The second floor has two 2/2 windows, and a single 2/2 window is found in the gable end which is articulated as an open-bed pediment with simple raking eaves, and a bottom eave that projects. Each side gable end is similarly articulated. A shed is found at the rear of this property.

This house was built by Henry Sanderson in 1900 on land he had recently purchased from Cheney Brothers (32/35). The form of this two-family dwelling, with its side entry porches is quite typical for Manchester, as has already been noted by Barbara Lewis.

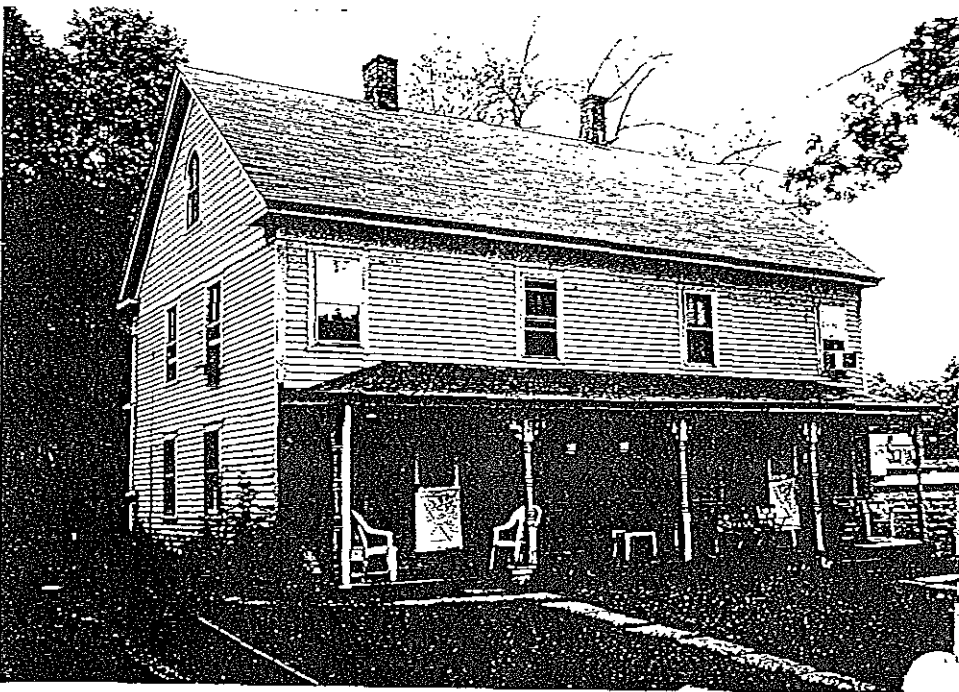
11. NUMBER OF STORIES 2		APPROXIMATE DIMENSIONS 45 x 28	
12. CONDITION (Structural)		(Exterior)	
<input type="checkbox"/> Excellent <input checked="" type="checkbox"/> Good <input type="checkbox"/> Fair <input type="checkbox"/> Deteriorated		<input type="checkbox"/> Excellent <input checked="" type="checkbox"/> Good <input type="checkbox"/> Fair <input type="checkbox"/> Deteriorated

With the exception of the spacing of the window bays, this Italianate house is virtually identical in type and decoration to 21-23 Gorman Place, immediately to its west, a Manchester rectangular plan double house. This house retains its original turned post and bracketed porch elements, and the hipped roof of the porch is still surfaced with tin. The two-story, gable-roofed, four-bay, two-family house rests on a brick foundation, is surfaced with clapboard at the first and second stories and wooden reversed imbricated shingles at the gable ends. The gable ends are articulated as wide, open-bed pediments with deep overhanging eaves and returns and contain round arched windows with 2/2 sash. Fenestration throughout consists of 2/2 sash with simple surrounds. The entries are flanked by the window bays of the ground floor, and the entries are hidden by modern storm doors.

All of the houses on Gorman Place appear to have been built by either Frank Cheney or Patrick Gorman on land purchased from Cheney. Patrick Gorman began purchasing land from Frank Cheney as early as 1875 and continued to purchase parcels in the same area until 1892. They are all quintessential Cheney workers housing types and should be noted for their unifying ground floor porches, Italianate windows in the gable ends, imbricated shingles and 2/2 windows.

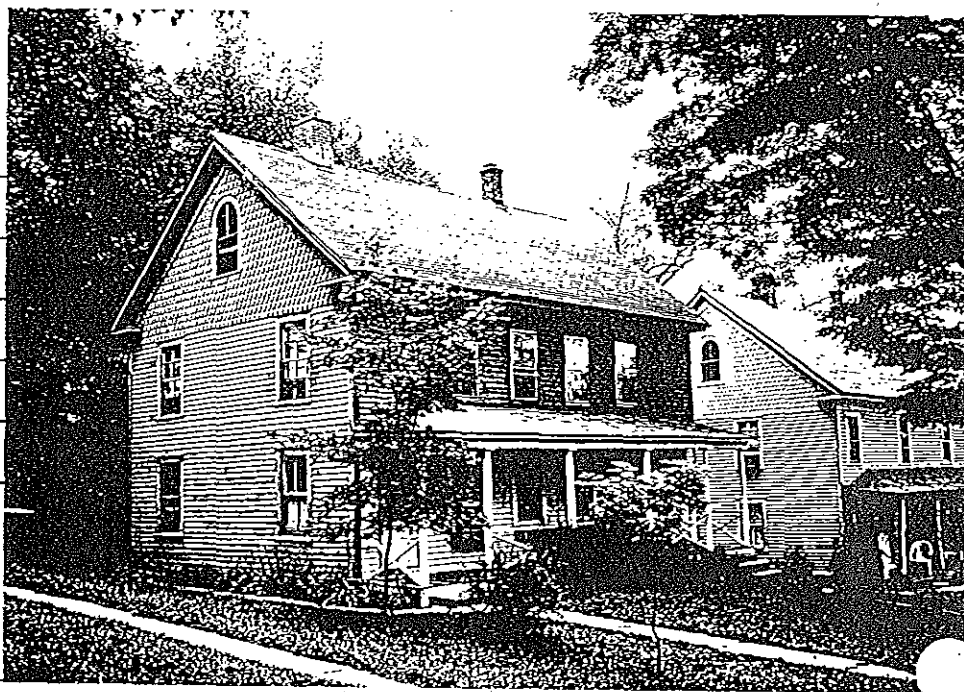
11. NUMBER OF STORIES 2		APPROXIMATE DIMENSIONS 36 x 25	
12. CONDITION <i>(Structural)</i>		<i>(Exterior)</i>	
<input type="checkbox"/> Excellent <input checked="" type="checkbox"/> Good <input type="checkbox"/> Fair <input type="checkbox"/> Deteriorated		<input type="checkbox"/> Excellent <input checked="" type="checkbox"/> Good <input type="checkbox"/> Fair <input type="checkbox"/> Deteriorated

13. INTEGRITY <i>(Location)</i>		ALTERATIONS	
<input checked="" type="checkbox"/> On original site <input type="checkbox"/> Moved WHEN?		<input checked="" type="checkbox"/> Yes <input type="checkbox"/> No IF YES, EXPLAIN porch elements replaced

Similar in type to 78-80 Linden Street, this Italianate house is another example of the rectangular plan double house and is in nearly original condition. The two-story, gable-roofed, four-bay, two-family house rests on a brick foundation, is surfaced with clapboard at the first and second stories and wooden "V"-grooved shingles at the gable ends. The gable ends are articulated as wide, open-bed pediments with deep overhanging eaves and returns and contain round arched windows with 2/2 sash. Fenestration throughout consists of 2/2 sash with simple surrounds. The entries are located at the outer of the six ground floor bays and have modern doors. The five-bay, hip-roofed porch is supported by Tuscan columns which are now united by a modern cross-braced balustrade.

All of the houses on Gorman Place appear to have been built by either Frank Cheney or Patrick Gorman on land purchased from Cheney. Patrick Gorman began purchasing land from Frank Cheney as early as 1875 and continued to purchase parcels in the same area until 1892. They are all quintessential Cheney workers housing types and should be noted for their unifying ground floor porches, Italianate windows in the gable ends, imbricated shingles and 2/2 windows.

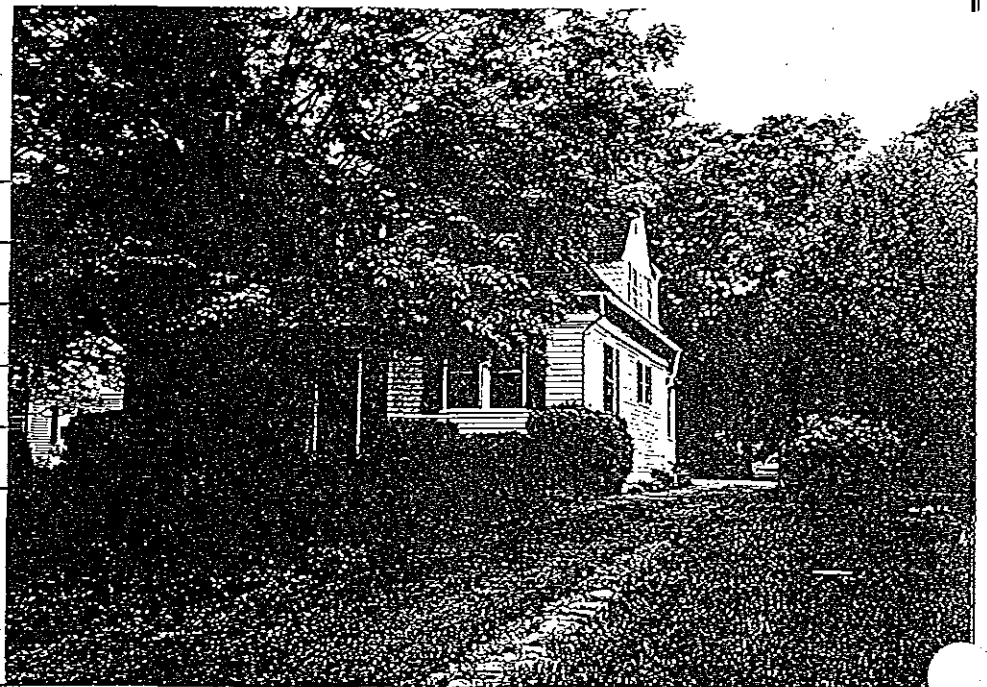
This two-and-one-half-story, hip-roofed, three-bay, transitional Queen Anne/Colonial Revival residence rests on a stucco-surfaced foundation. The building has a rear wing that is gabled. The ground floor is clapboard-surfaced, with paired 6/6 windows flanking a central entry that is, in turn, flanked by simple pilasters. There is a belle-cast, clipped-shingle skirt that extends around the house beneath the eaves and up into a central, cross-gabled dormer. This dormer is further articulated by a pair of 9/9 windows.

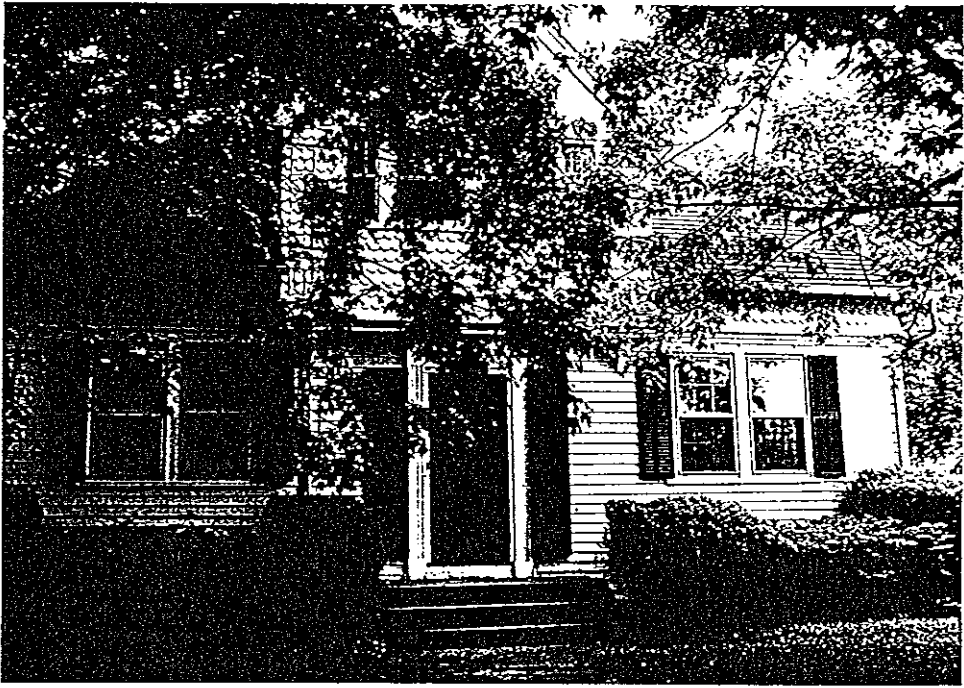
27 Otis Street
Manchester, Connecticut
Continuation Sheet

This is a massive, Queen Anne, Manorial style dwelling, wood framed and resting on a brick foundation. The main entrance is away from the street, facing west, and is articulated as a large, Tuscan wrap-around porch that terminates in hexagonal bays, and that carries a denticulated cornice. The ground floor, generally speaking, is surfaced with clapboards that terminate in cornerboards and the second floor is denoted by a belle-cast skirt surfaced with imbricated shingles. Above this is another band of matchbox coving and various other decoration that delineate the bottoms of the gable ends. The building's roof is a riot of asymmetrical, gable and jerkinhead projections whose gable ends are surfaced with a variety of half-timbering, shingling, sunburst motifs, fanlights, and windows, eared and footed windows and curving brackets, as well as a variety of eave molding. Projecting through the roof are numerous brick chimneys with Tudor Revival chimney pots. Fenestration, for the most part, is 2/2, has simple surrounds, and with the exception of aluminum storm sash and some jalousie windows at once-open porches, and a series of skylights on the east facing rooms, the house retains original fenestration. The exterior of the house survives with a high degree of integrity despite its conversion to multi-family use.

Although converted to apartments, this massive Queen Anne Home has retained most of its marvelous exterior detail as described in part 17 and should be considered architecturally significant as such. It is further significant as the home of Robert O. Cheney, one of the founders of Cheney brothers. Although its context has been compromised by the construction of apartments and mid-20th century dwellings, it has retained sufficient integrity to be considered a contributing element in any historic district expansion.

the porch level, the entry door is not visible, but to its east, the porch is supported by an oversized, incised arched bracket. A bay window with four narrow 1/1 sash is found to the west; another large bracket decorates the porch. At the ground floor, behind the porch at the southwest corner is a two-story, octagonal bay with a jerkinhead roof. On the south, a two-story wing, topped by a clipped jerkinhead roof, projects from a larger, cross-gabled wing which has coved and fluted barge boards and a sunburst in the gable end. To the west of this is a smaller gabled dormer with a single 2/2 window, topped by a tiny, triangular, stylized sunburst decoration. A two-and-one-half-story, gable-roofed wing projects toward Otis street. At the Otis Street elevation, the original rear elevation, the deep overhanging eaves of the hipped roof are supported by projecting rafter ends. A one-story, one-bay, Doric entry porch is found in the corner formed by the south and east wings. Another rear entrance, located on the eastern corner of the building contains a door with 20-light sash and a belle-cast hip roof supported by prominent brackets. A three-sided, hip-roofed dormer projects from the roof at this elevation.

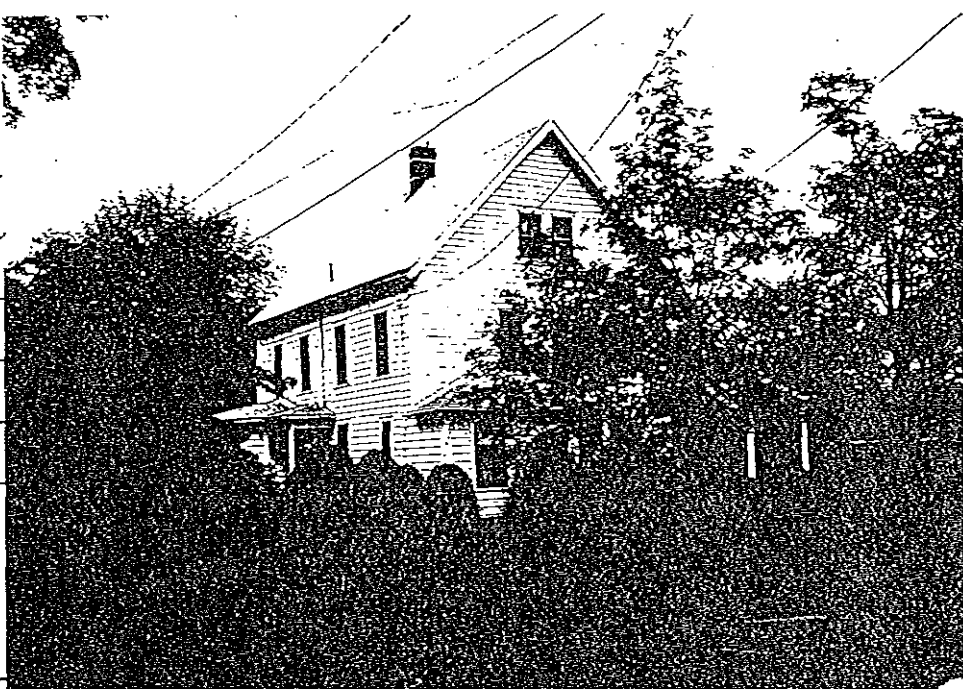
This is a large, gable-roofed, two-family house that is surfaced with wood shingles and rests on a brick foundation. A double pitch gable subsumes a two-bay Tuscan entry porch. Most of the fenestration is Queen Anne in style. There is a one-story, one-bay, hip-roofed bay at the facade. Projecting shed dormers with rafters with birds-mouth ends project from the eastern side of the roof. The barge boards of the gable ends are supported by curving, incised brackets. An original, one-story, hip-roofed projecting bay is found on the west side elevation.

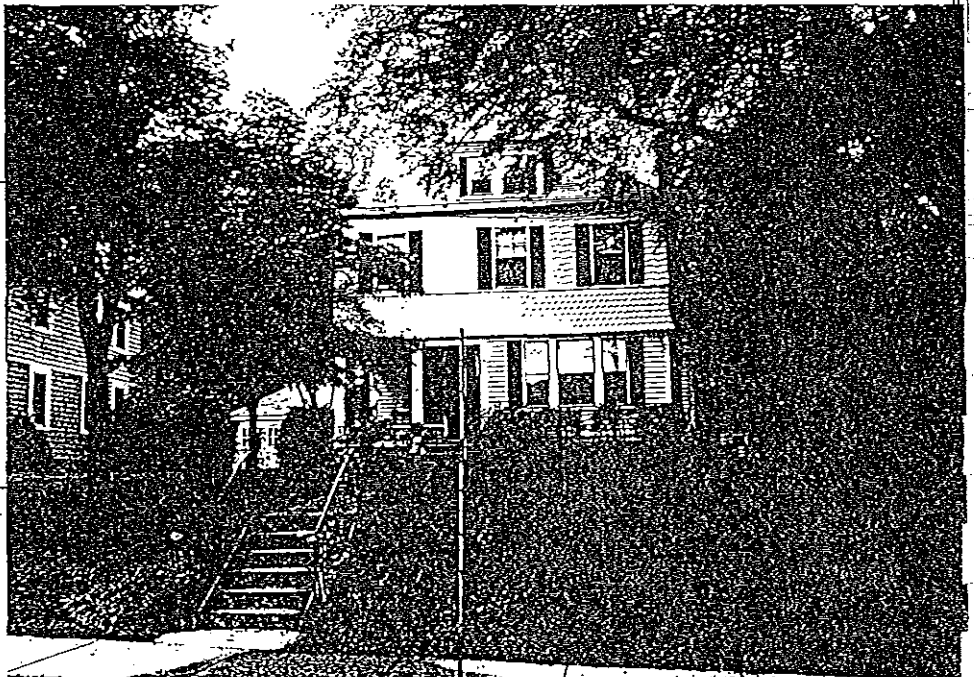
This is a hip-roofed, two-and-one-half-story, three-bay transitional Queen Anne/ Colonial Revival building that is surfaced with clapboards at the ground floor and shingles above, and that rests on a brick foundation. The ground floor clapboards terminate in corner boards, at the second floor, a wide skirt of hexagonal shingles splays out over the ground floor; above which the second story is surfaced with clipped shingles. A hipped dormer that enframes paired 4/4 windows projects from the roof. Second floor fenestration is 4/4 as well. Below the skirt between the first and second stories, on the west side is a two-bay, wrap-around Tuscan columned porch which shelters the recessed entry. To the east of this is a triple window consisting of a 4/1 window flanked by smaller 4/1 windows. On the western facade is a two-story, projecting bay and a side entry.
