Manchester, Connecticut
West Side Neighborhood Cultural Resource Survey

May 1995

Sponsored by the Town Of Manchester

Connecticut Historical Commission

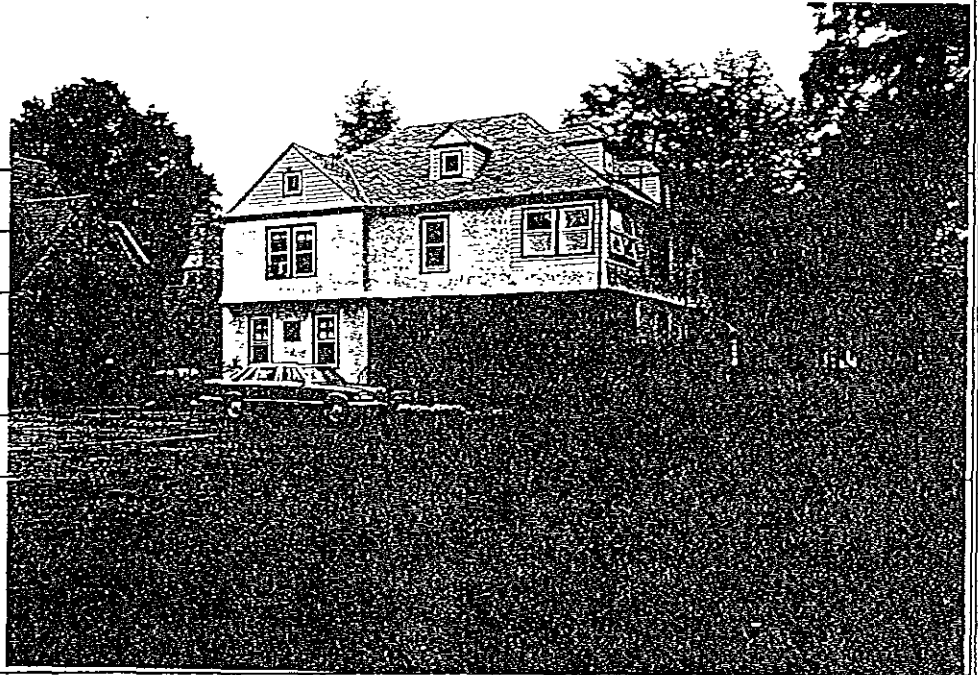
The eaves of the second story are belle cast; above the entry is a single window and paired windows at the corner which appears to have originally been an open porch, but is now enclosed with vinyl siding. A gabled dormer articulated as a closed bed pediment projects from the roof at the facade elevation and paired dormers project from the east side. A one-bay, shed roofed entry porch is also found on the east side elevation.

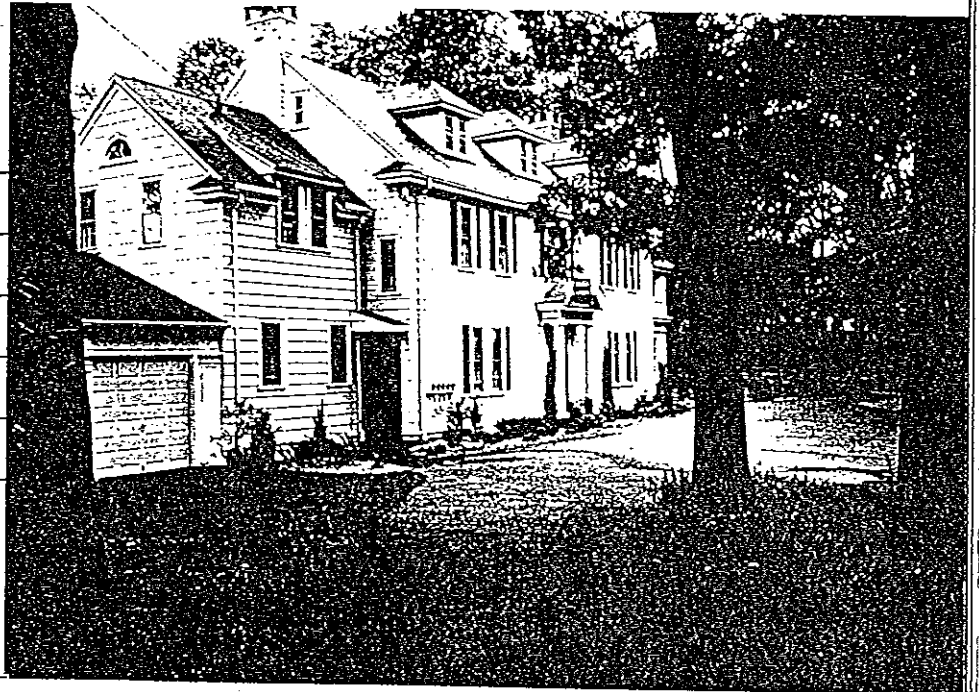
This is a three-bay, two-and-one-half-story, Colonial Revival building that rest on stone sills. Its has a central, Colonial Revival entry with Tuscan columns supporting a broken-arched pediment that enframes a false balcony railing. The central entry is flanked at the ground floor by paired, 6/6 windows. The second floor has paired 6/6 windows flanking a central window. The gable roof is pierced by three hip-roofed dormers with paired 2/2 sash. The gable ends of the building contain tiny 4/4 windows. The main section of the building is flanked by paired, two story, gabled wings that are less tall than the main section. The eastern wing has a shed dormer with paired windows, and a lunette window in the gable end, which has strong, deep, returns. The western wing is articulated by a simple entry with a horizontal pediment. There is a modern, two-car garage addition to the eastern side, the decoration of which mimics the semi-circular ball motif found on the main entry.

This house was built by William Cheney about 1916 (146/385). Now converted to apartments, this large Colonial Revival house should be noted for its massing and its imposing pedimented doorway. It is clearly significant as an excellent example of domestic architecture and for its long association with the Cheney family.
